ANDRONAS  
CONSERVATION  
ARCHITECTURE

## **Conservation Management Plan May 2011**

## **Penitentiary Precinct Port Arthur Historic Site Tasmania**

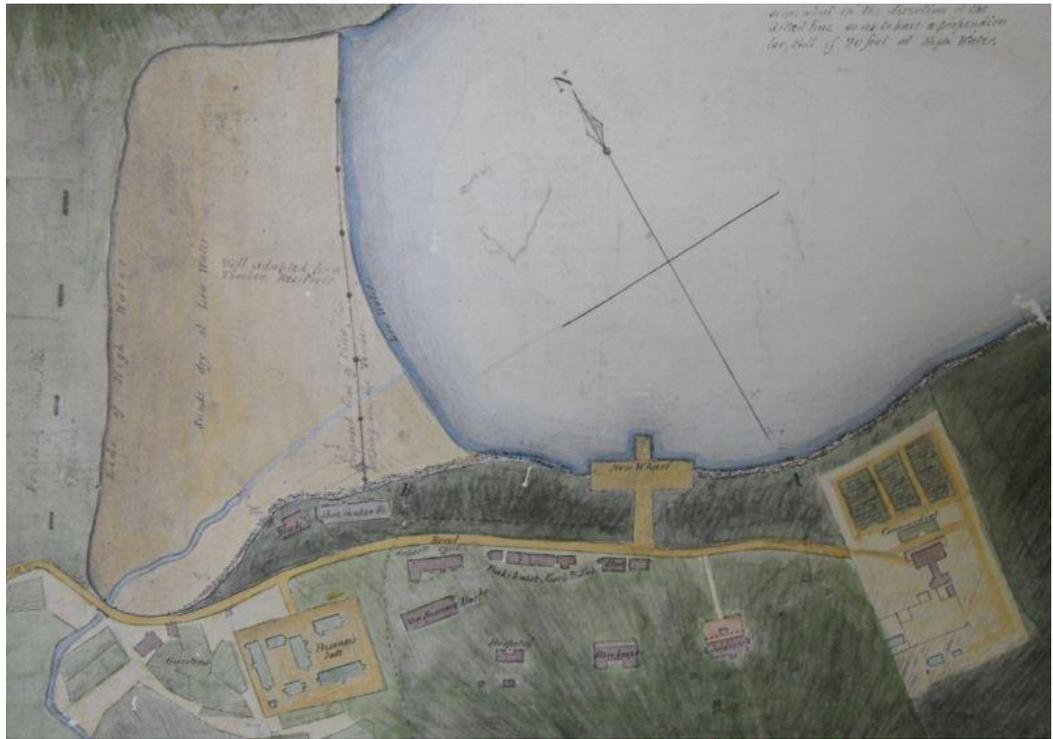
**Figure 2.** Detail from J.W. Hughes 1833, 'The Settlement of Port Arthur' showing the Shoemakers' and Blacksmiths' Shops erected in 1831 on the south side of the cove. Note that they are located on the edge of a sandy area submerged at high tide, which was later reclaimed. (PAHSMA ref. HM 1833/1)

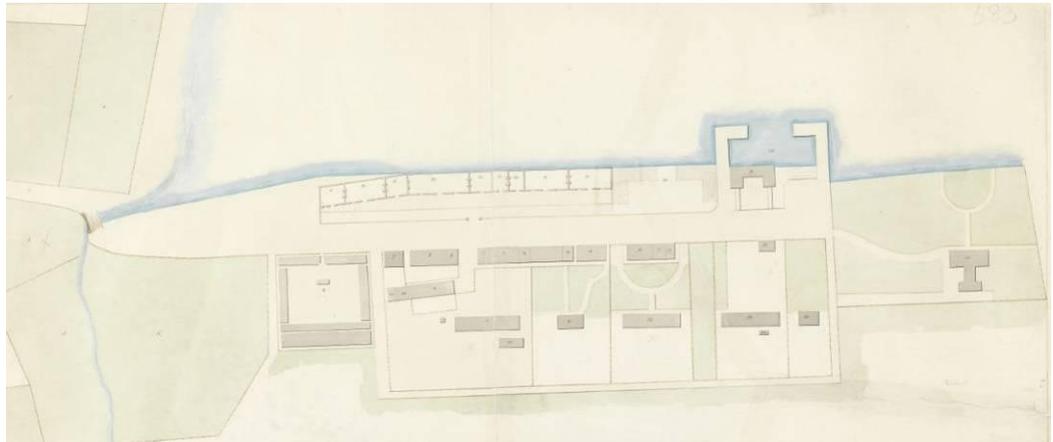
**Figure 3.** Detail of 1836, 'Plan of Settlement: Port Arthur', 1950s tracing. The workshops in the long, narrow building located along the water's edge are, from right to left: Invalid Room, Carpenters' Shop, Coopers' Shop, Wood Turners' Shop, Tailors' Shop, Shoemakers' Shop, Nailers' Shop, Blacksmiths' Shop, and Store room for iron. (PAHSMA ref. HM 290/1459)

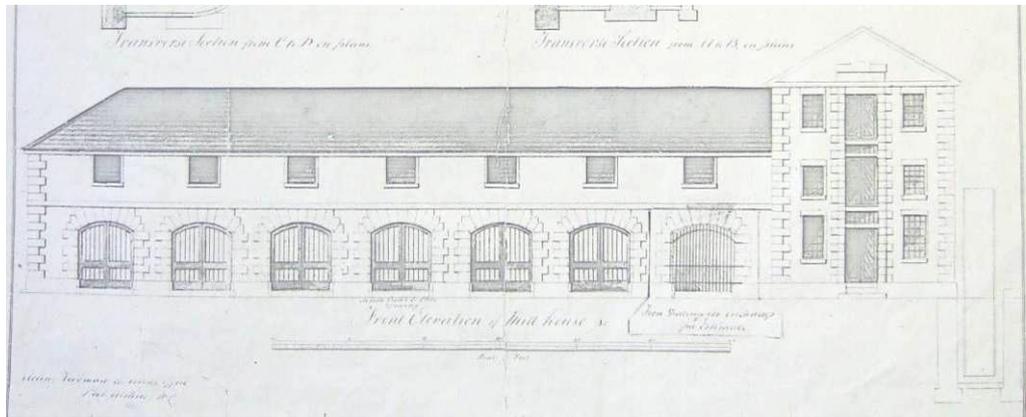
**Figure 5.** Detail of Henry Laing's c1841 plan for a combined granary (left) and mill (right). Note the external waterwheel on the right side of the mill. (PAHSMA ref. HT-290/1483)

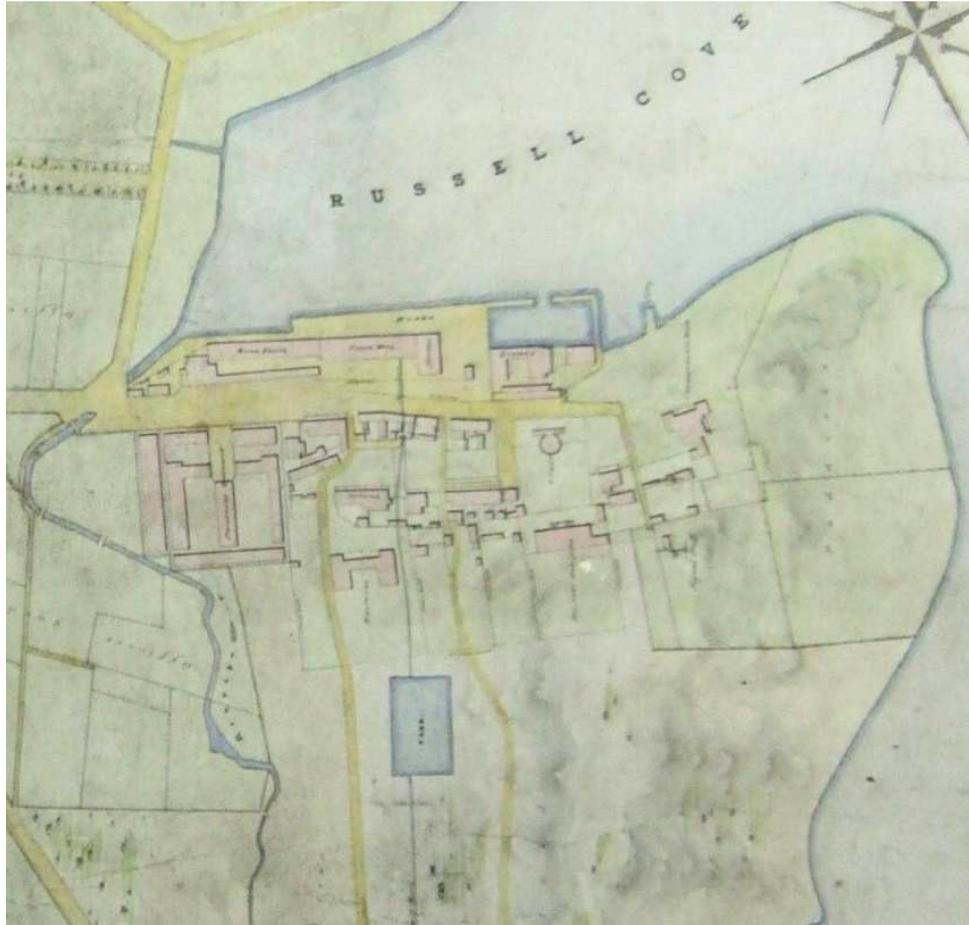
**Figure 6.** Detail of 'Plan of the Penal Settlement at Port Arthur', 1846, showing the reservoir (centre) and the path of the aqueduct down to the Flour Mill. (PASHMA ref HM 1846/1)

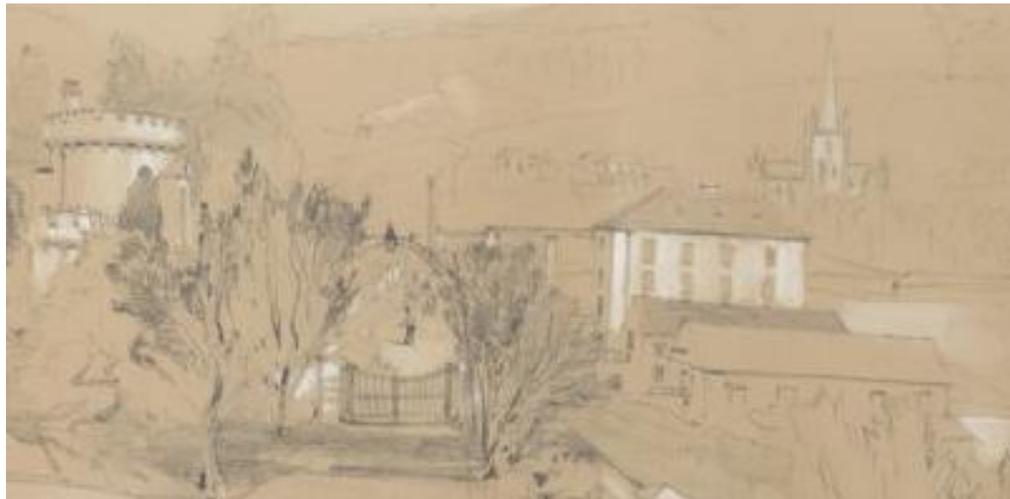
**Figure 7.** Detail from John S Prout's sketch 'The settlement, Port Arthur, V.D.L., from the commandant's residence, May 20, 1845', showing (from left to right) the siphon rising up south of Champ Street, and two support pillars (on either side of Champ Street) supporting the flume which then enters the Flour Mill at eaves level. (National Library of Australia, nla.pic-an2479033)

Late in the proceedings, well after the completion of the mill house and waterwheel in November 1843, the design of the final section of the millrace was decided. In February 1843, Clark proposed continuing the water pipe under Champ Street, and to then raise the water in a pipe (with a siphon) up to a flume leading to the top of the waterwheel. This was altered in February 1844 to the plan as finally executed: the water would be raised to the south of Champ Street, crossing above the buildings on its south side and the street itself in a trough, and then continuing over the mill yard. The flume-trough was supported on three stone pillars. The base of two pillars survive: one is part of the retaining wall just south of Champ Street (within the Penitentiary precinct), and the other is just north of Champ Street. While pictorial and physical evidence points to a rise in the piping on the north side of Champ Street, an essay on 'Water Reticulation at Port Arthur' notes that there are also documentary sources that indicate that there was a rise on the south side instead.

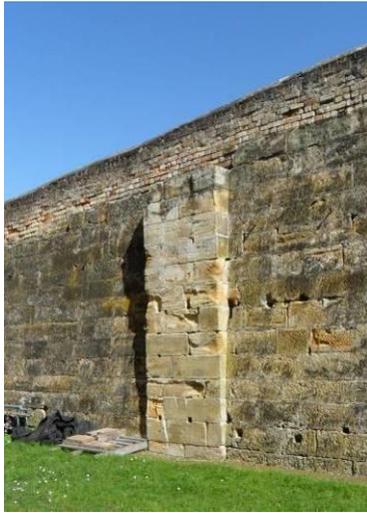
**Figure 8.** Left: Base of the flume pillar in the Champ Street retaining wall enclosing the rear wall of the Penitentiary (Andronas Conservation Architecture, 2010).

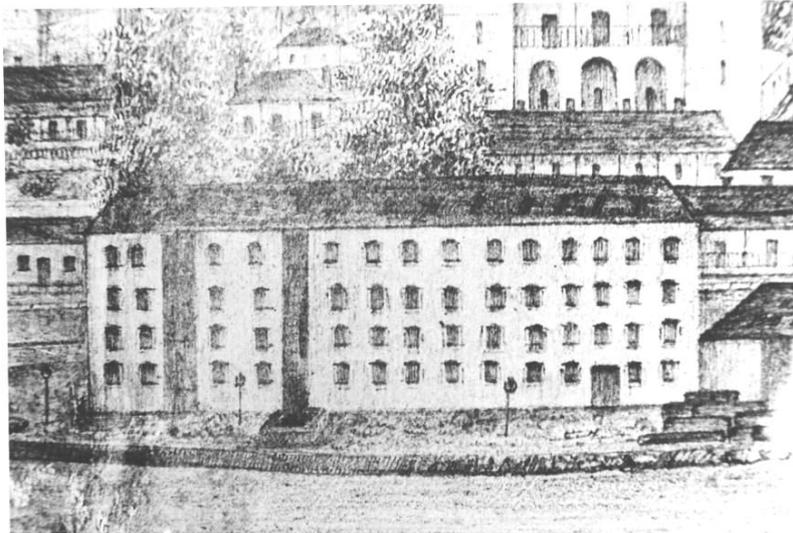
**Figure 11.** Detail sketch of the Granary and Mill, c1851-52, after the watercolour by Benjamin Duterrau.. Note the vertical loading bays to the Granary on the left side and the waterwheel protruding from the Mill building to their right. The treadwheel ward was on the right end. (PAHSMA ref 1369)

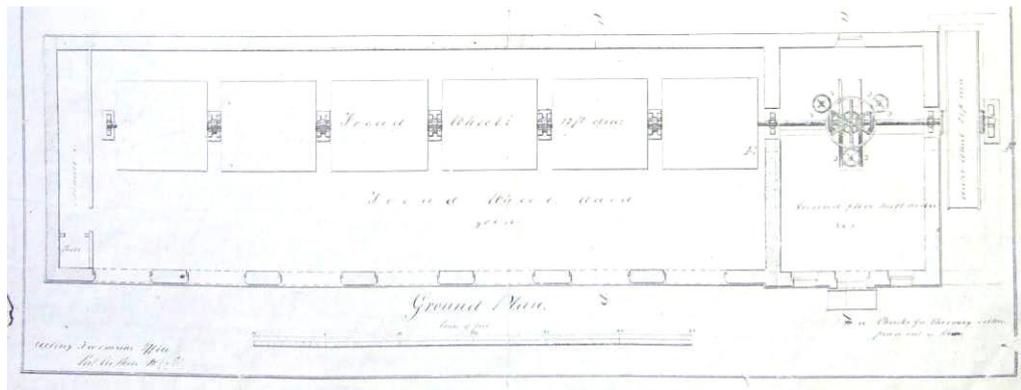
**Figure 12.** Detail of Laing, c1841, 'Design for a Corn Mill prepared to be erected at Port Arthur to be propelled other by the power of water on a Tread wheel'. Plan of the ground floor showing the six sections of the treadwheel on the left and a waterwheel on the right, both linked by shafts to the mill gears at the centre. (PAHSMA ref. HB-290/1482)

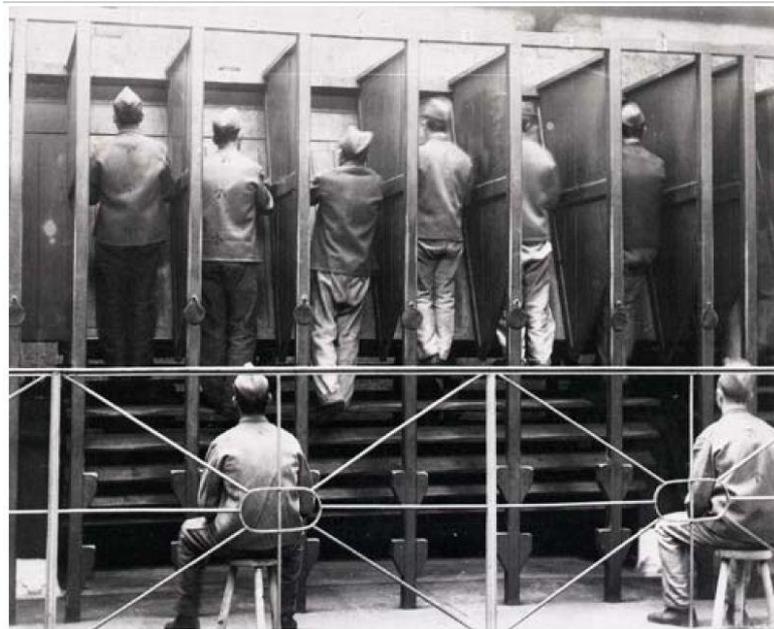
**Figure 13.** A treadwheel in operation at Pentonville Prison, London, 1895. The one at Port Arthur would have been similar. (Reproduced in Tierney, *Notes of Port Arthur's Tread Wheel*, 2009)

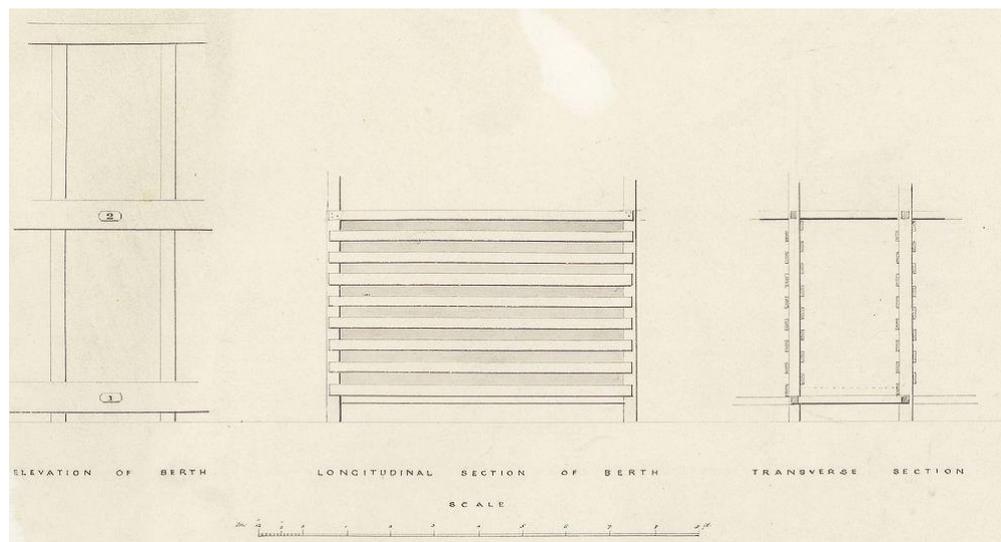
**Figure 14.** Detail of the 'separation cage' bunks in the Penitentiary, c1864, showing an elevation and details of the staggered battens between them. (PAHSMA ref HB P No 1)

These men slept in two tiers of 'separation cages' ranged along the north and south walls of the top-floor dormitory, separated by a wide passage lit all night by kerosene lamps suspended from the open roof trusses. From the c1864 drawings, it appears that it was only located in the long east-west part of the building and not in the south return (though errors have been found in this set of drawings). This is strengthened by a mention by the Comptroller General of 'one long dormitory' in 1848.<sup>43</sup>

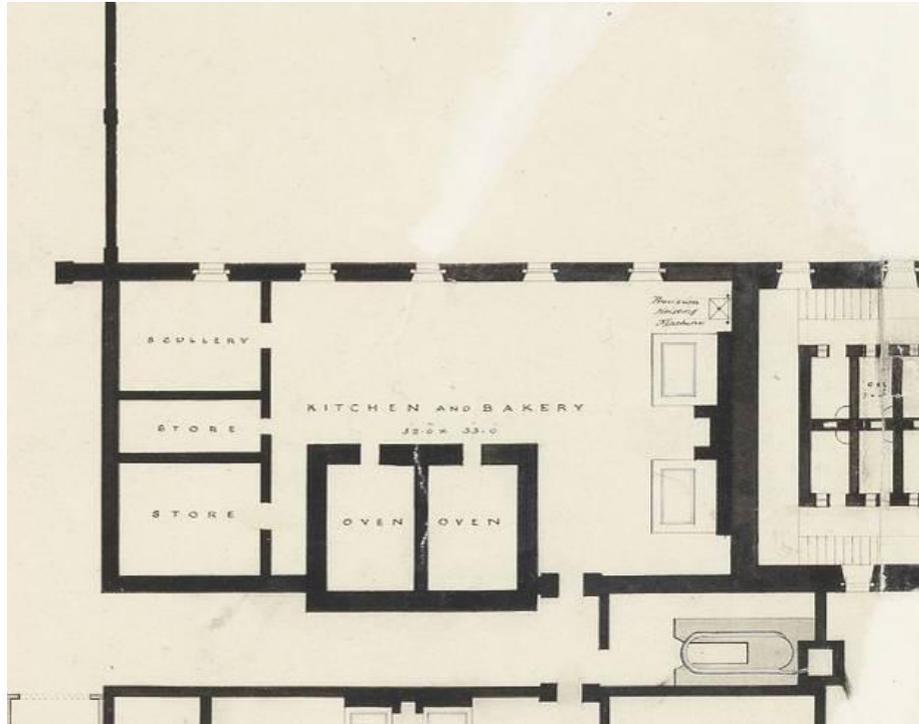
**Figure 20.** Plan of the Bakehouse, c1864. The bake ovens are visible on the south wall and the cooking ovens on the east (right) wall. The boiler and square chimney are located south of the cooking ovens. (Archives Office of Tasmania, ref. PWD266-1-1779)

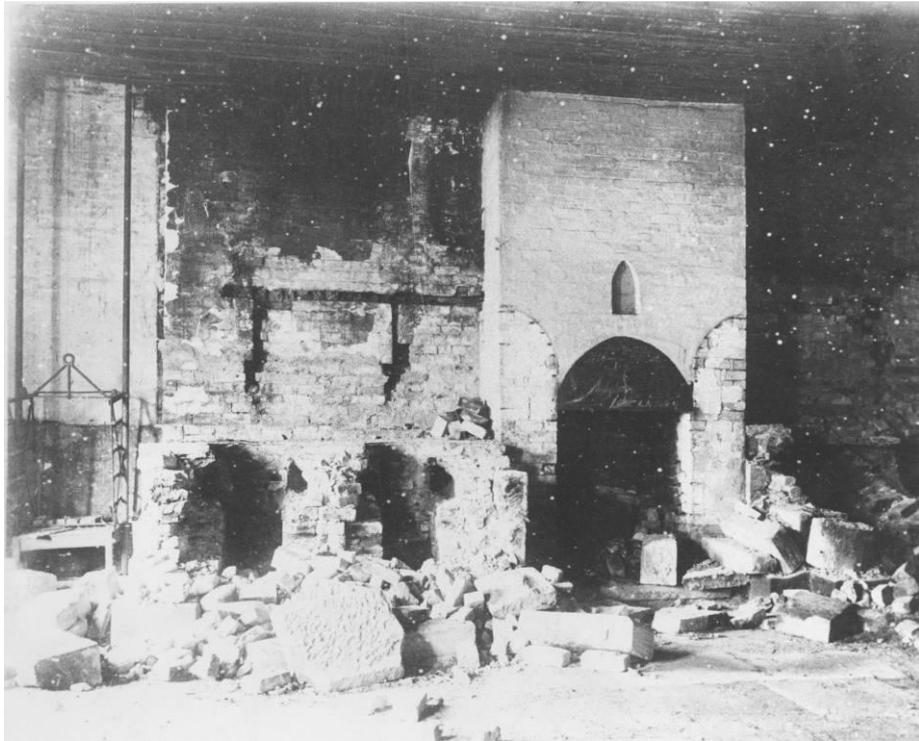
**Figure 21.** Interior of the kitchen, looking east, c1880s. The food hoist is visible at far left, as well as the location of three of the four cooking ovens (with coppers removed). (PAHSMA ref 2845)

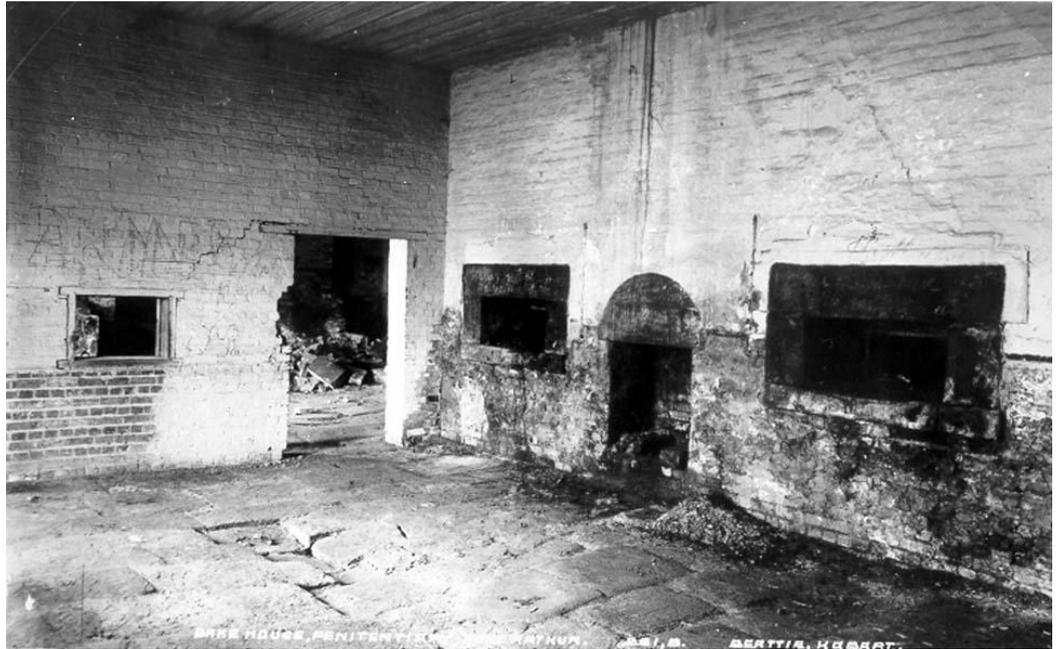
**Figure 22.** View of the baking ovens, looking south-east, c1880s. Note the wall separating this room from the cooking ovens (left). (State Library of Tasmania, image NS1013-1-1645)

As shown in an 1880s photograph (below), the baking and cooking spaces were divided by a wall. It is not shown in the c1864 plans (Figure 20), so it may have been added later, or may be yet another error in these plans.

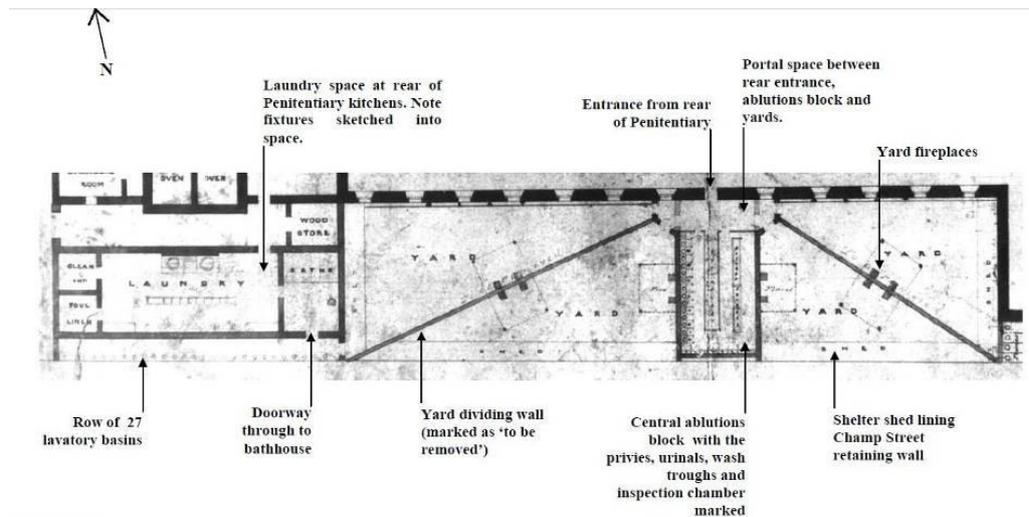
**Figure 23.** Plan of the ablutions area, c1856. (Tuffin, 'Penitentiary Ablutions Block Archaeological Report, 2004)

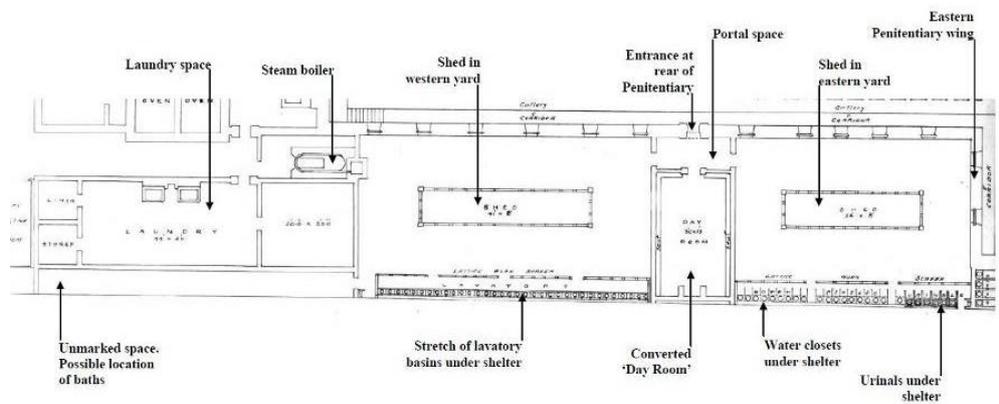
**Figure 24.** Alterations to the ablutions area and creation of the day room, c1864. . (Tuffin, 'Penitentiary Ablutions Block Archaeological Report, 2004)

east side of the yard. A row of 34 washing basins was in the western shelter. The privies located behind the Laundry were removed and are believed to have been replaced with baths. The bathtubs were removed from the room at the east end of the Laundry, and this space may have become a clothes drying room.

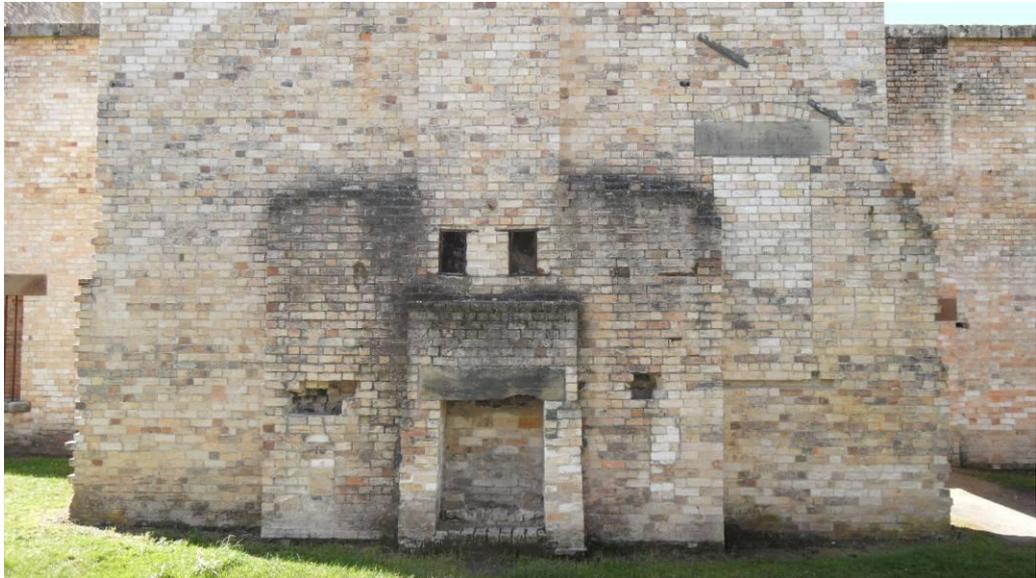
**Figure 25.** *The surviving north wall of the Laundry. The fireplace for boiling water is at centre, ground level. To the right is an elevated doorway (indicated by a stone lintel), now bricked in. (Andronas Architecture, 2010)*

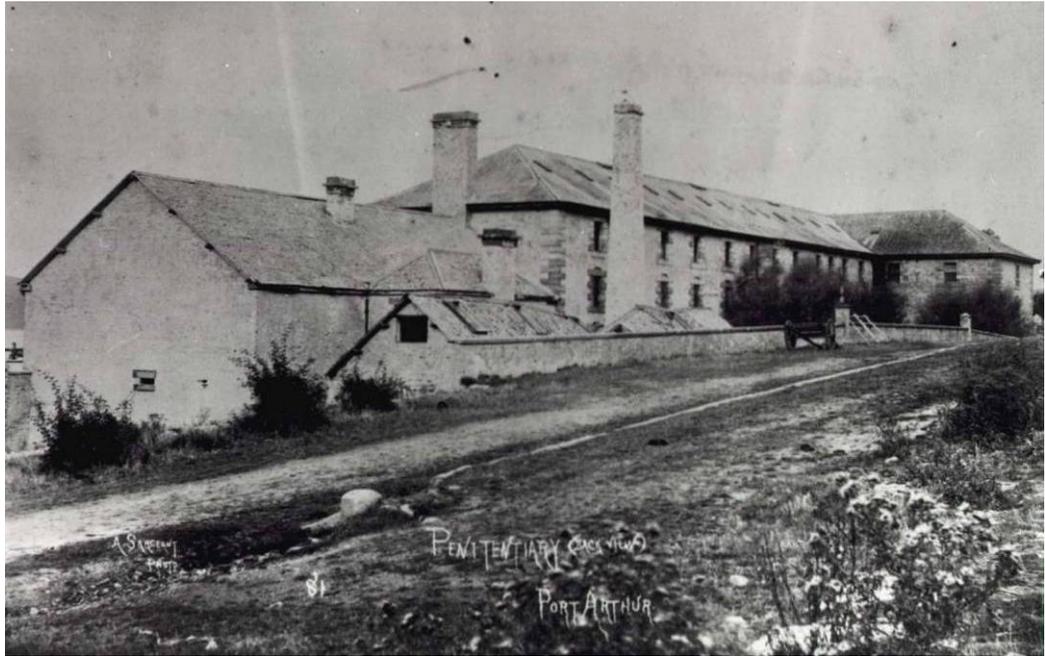
**Figure 26.** View of the Laundry and Bakehouse from Champ Street, looking north-east, after 1864 when the laundry and kitchen digester boiler was installed (note its free-standing chimney). Note the small, hipped-roof structure linking the two building – this may have been the drying room. (PAHSMA ref 66-1030)

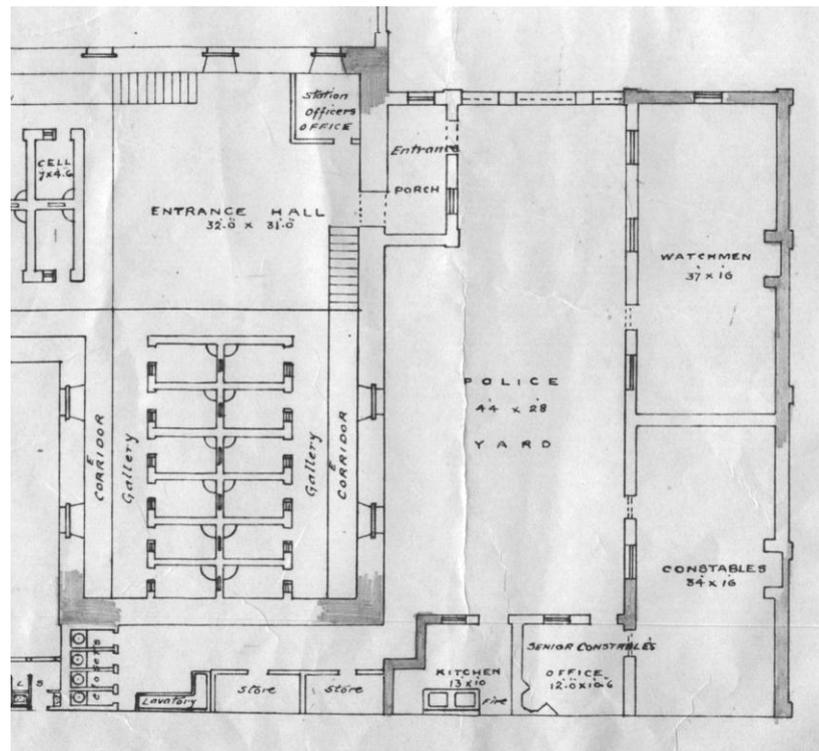
**Figure 27.** Plan of the Watchman's Quarters at the east end of the Penitentiary, c1864. The watchmens' room is near the front of the 'Police Yard', behind is the constables' room. In the west wing is the Senior Constable's Office, a kitchen, two store rooms, a small laundry and four privies. It should be noted that the watchmen's room in fact ended in line with the south wall of the Penitentiary entrance porch, but has been drawn incorrectly. (PAHSMA ref HB P No 1)

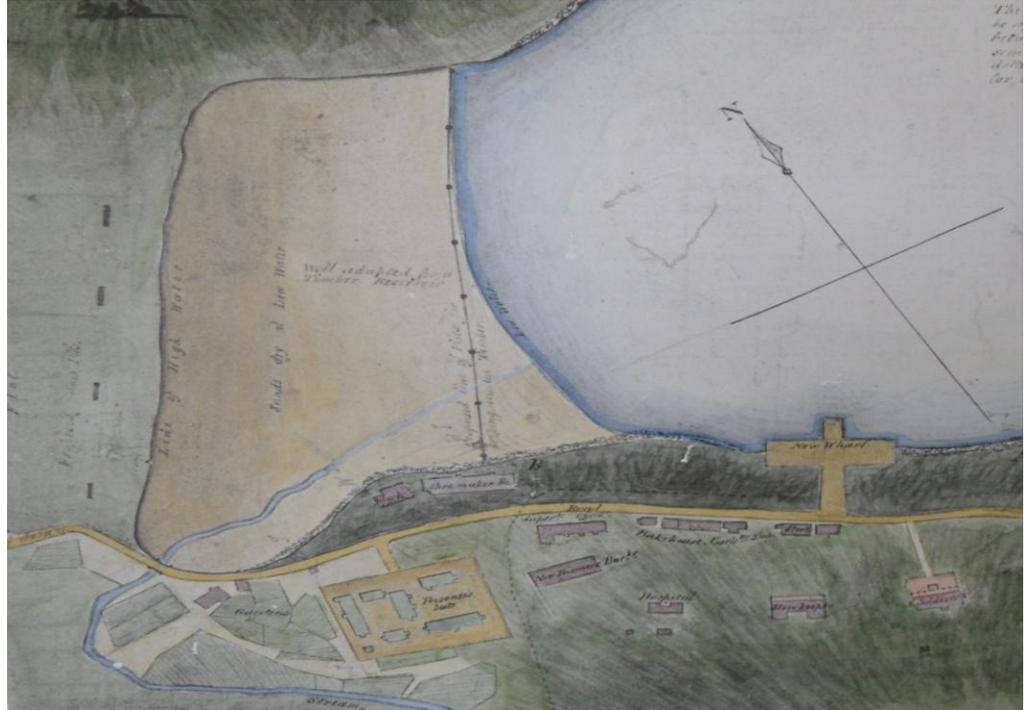
**Figure 28.** Detail of 1833 plan of Port Arthur showing the original extent of the sand exposed at low tide that was reclaimed in 1841 and 1854. (PAHSMA ref. HM 1833/1)

When the Granary and Flour Mill were built, they fronted a large cove on their north side, with the outlet of Settlement (Radcliffe) Creek located well to the west of the buildings at high tide (roughly where Champ Street crosses it). At low tide, however, a large area of sand was exposed (about two-thirds of the area since reclaimed). Proximity to the high-tide line and water's edge led to 'a constant undermining action on the foundations'.

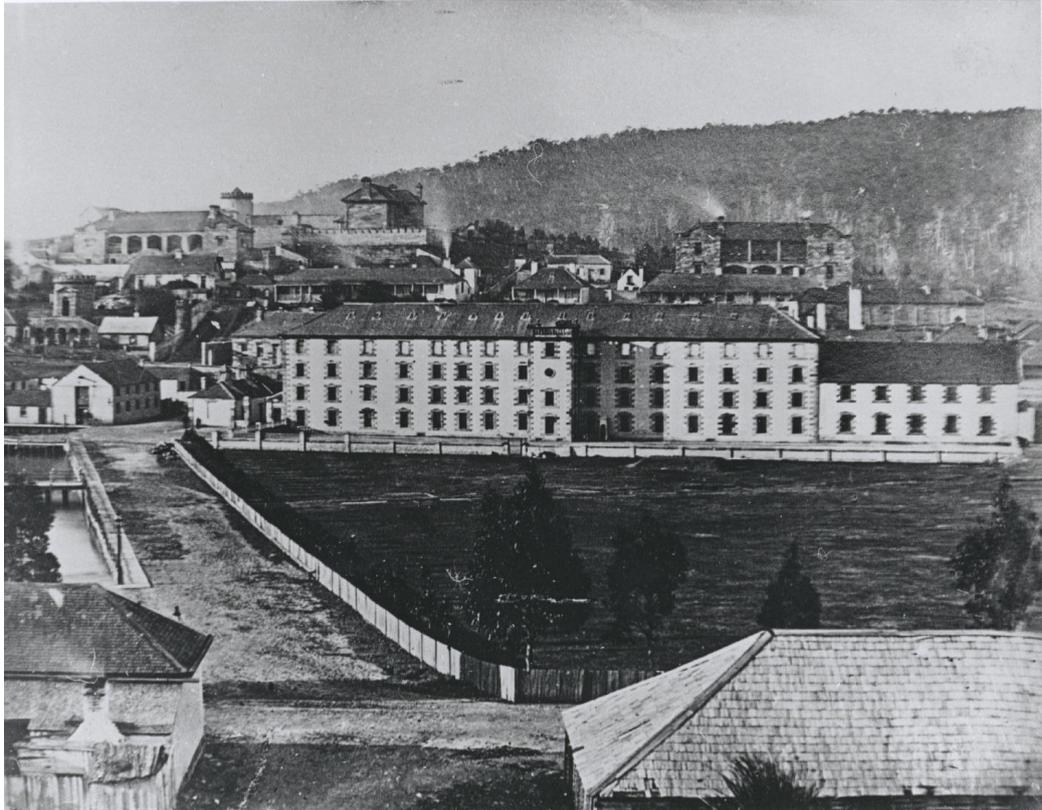
**Figure 29.** View of the Penitentiary c1860. The Parade Ground wall is visible before the Penitentiary, in front of which is the open grassed area and covered stream (just visible). The grassed area is surrounded by a paling fence. (PAHSMA ref 66-1855)

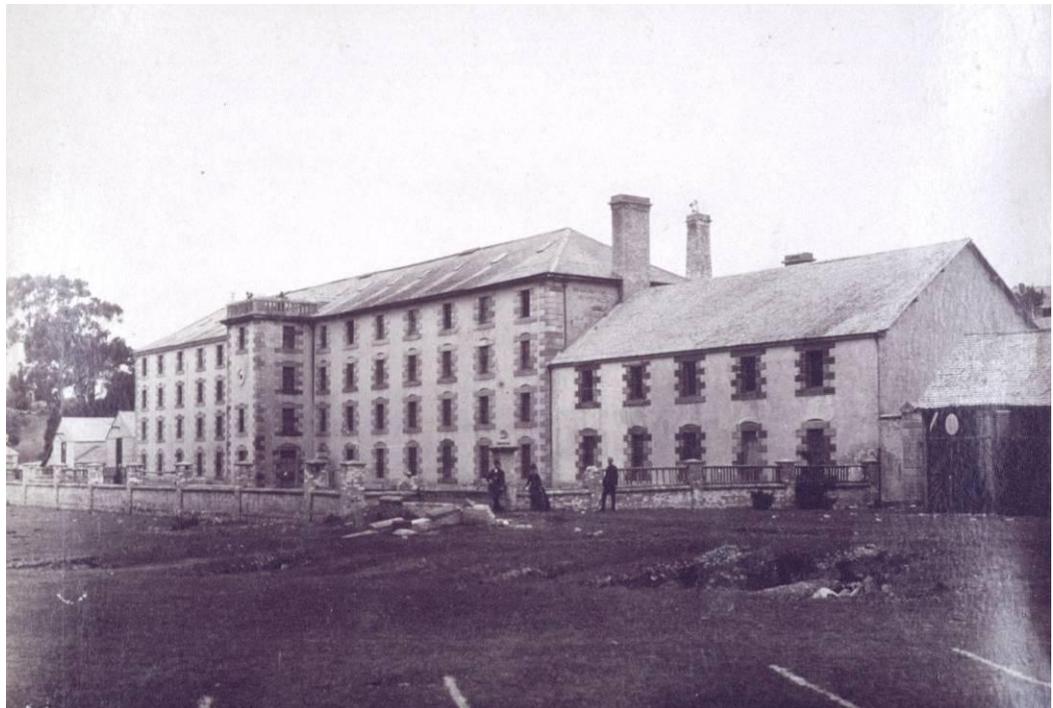
**Figure 30.** View of the Parade Ground, c1880s. The timber balustrade is visible at the west (right) end, as is the entrance gate to the Workshop Complex (far right). (State Library of Tasmania, image AUTAS001126184118)

Sometime between 1860 and 1863, the Parade Ground was further formalised and enclosed. The brick wall was continued along the eastern side, with one gate, and the entire wall was heightened by the addition of piers. In between the piers a decorative timber balustrade was installed. With the higher wall, in combination with iron gates, the Parade Ground could now effectively contain convicts.

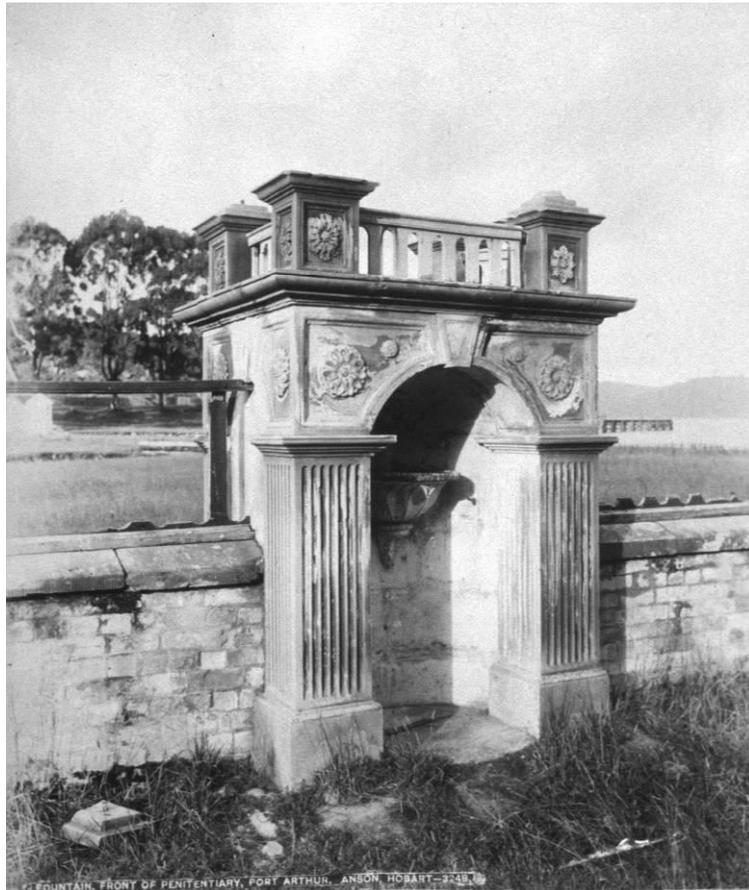
**Figure 31.** *The Parade Ground fountain, c1880s. Fragments of the timber balustrade are visible to the left, above the low brick wall. (State Library of Tasmania, image AUTAS001125643049)*

In the late 1860s, the north gate was closed up, and it seems that the tram tracks were removed around the same time. A large, ornamental sandstone fountain was then erected at the centre of the north wall, several metres west of where the gate had been. The fountain was square in plan with ornate piers at each corner. It was described as being 'like a pulpit, but which is a cistern where iron ladles on chains were available for the men to drink from'. Water was supplied through gutta-percha (a natural latex rubber) piping which had become unserviceable by the mid 1870s.<sup>63</sup>

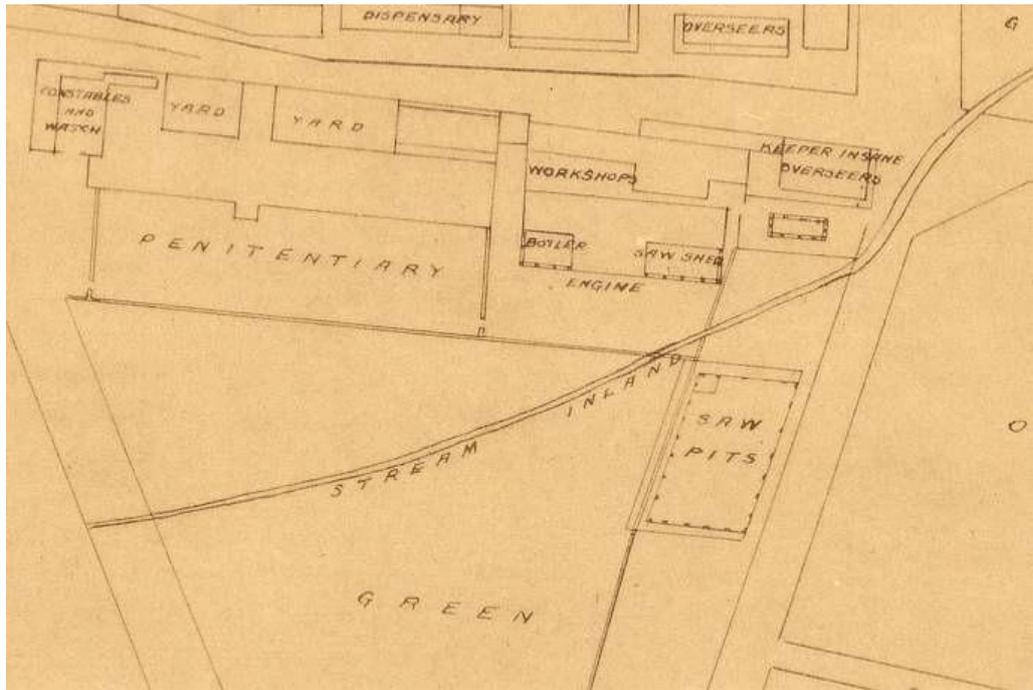
**Figure 33.** Site plan of the Penitentiary and new workshop complex, late 1850s. Note the surviving overseer's quarters at the west end of the site. Covered saw pits were built on the north side of Settlement Creek (which had been covered over). (Archives Office of Tasmania, ref. PWD266-1-1775)

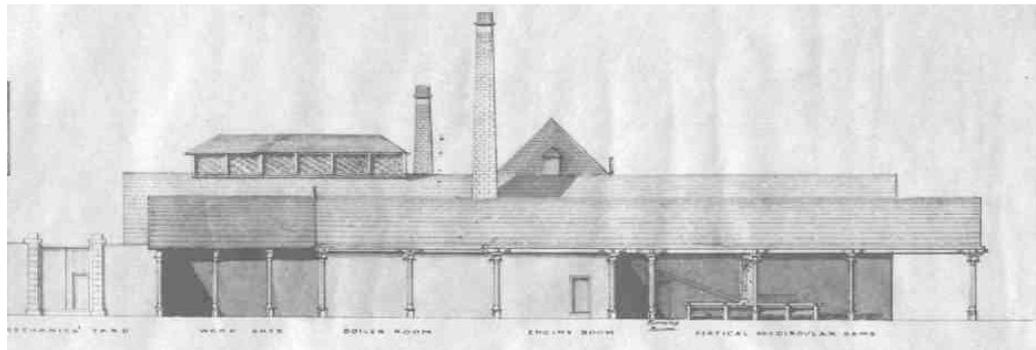
**Figure 36.** North elevation of the Workshops Complex, c1864. Note the boiler chimneys to the steam-engines. (PAHSMA ref HB P No 1)

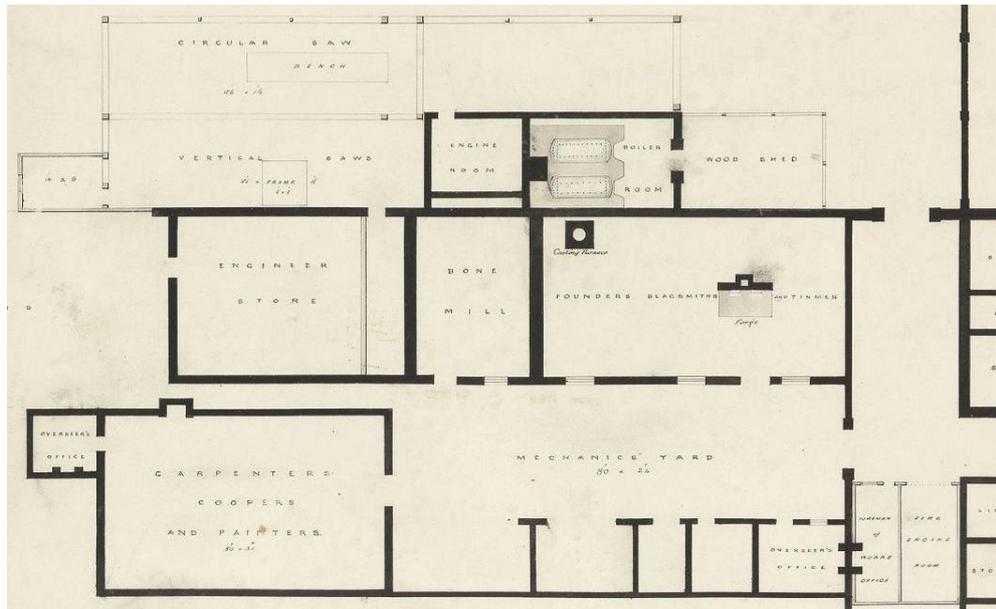
**Figure 37.** The new workshop complex, c1864. The sawmill (top two rows of rooms) contains spaces for a circular saw, a vertical saw, engine room, boiler room (with two boilers), and a wood shed. The central row contains an engine store, bone mill, and blacksmiths/foundry. The bottom row contains an overseer's office, carpenters', coopers' and painters' workshop, and a mechanics' yard with another overseer's office. In the space between the workshop complex and the Laundry (right) is the Foreman of Works' office and the fire engine room. (Archives Office of Tasmania, ref. PWD266-1-1779)

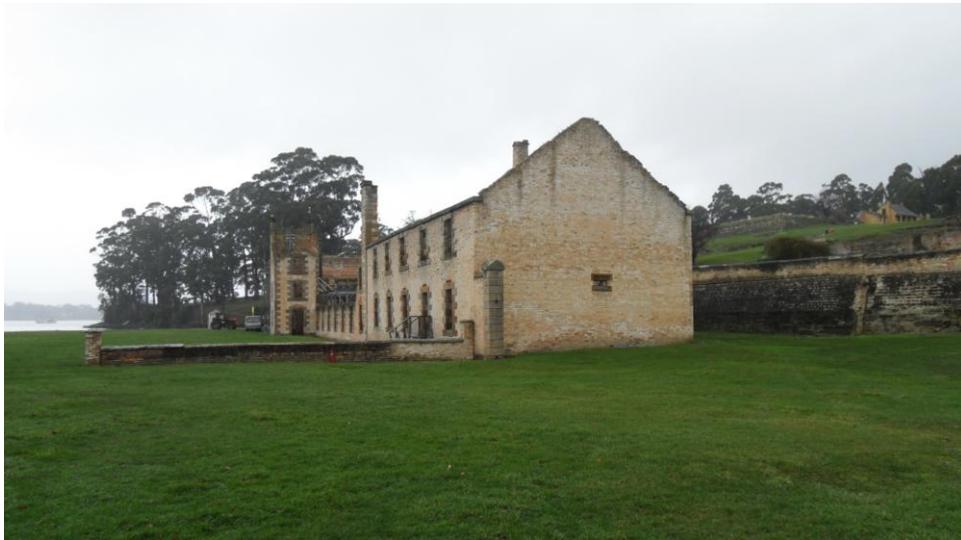
**Figure 46.** View of the west end of the Bakehouse building and a section of the parade ground masonry fence. [authors 2010]

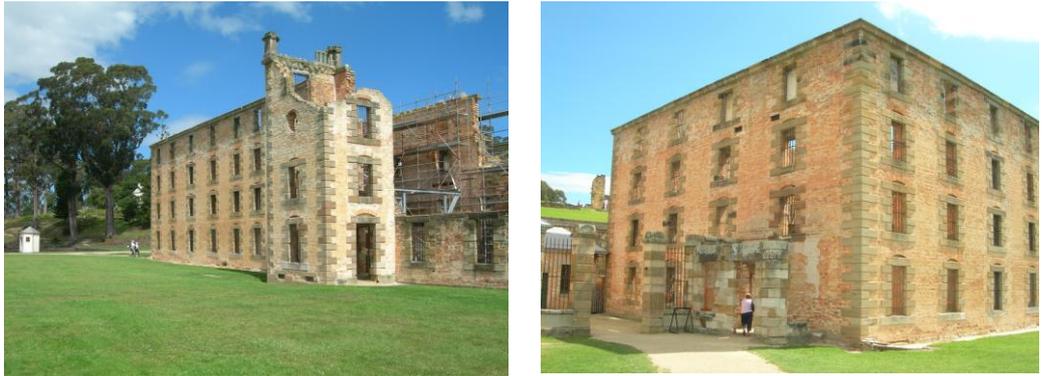
Slightly off centre in the northern facade is the ruin of the clock tower, also constructed during the penitentiary conversion phase. The tower not only housed the clock (external face) but provided an additional access stair connecting each level. The even number of bays and the adaptation of one of the windows to provide the access between the existing structure and the new tower resulted in the slight asymmetry to the north elevation. The materials and form of the tower followed the existing granary/mill building being of locally made bricks with stone dressings including quoins and voussiors. Parts of the existing tower ruin are reconstructions and the original tabilizat parapet no longer exists. Further west along the northern facade remains a section of wall which is only 2 storeys high. This section had substantially collapsed following the fire and was further removed during the mid twentieth century to gain access to clear the interior rubble and was then reconstructed.

**Figure 51.** View of the tower (left image) and the east wall of the Penitentiary ruin (right) [authors 2011]

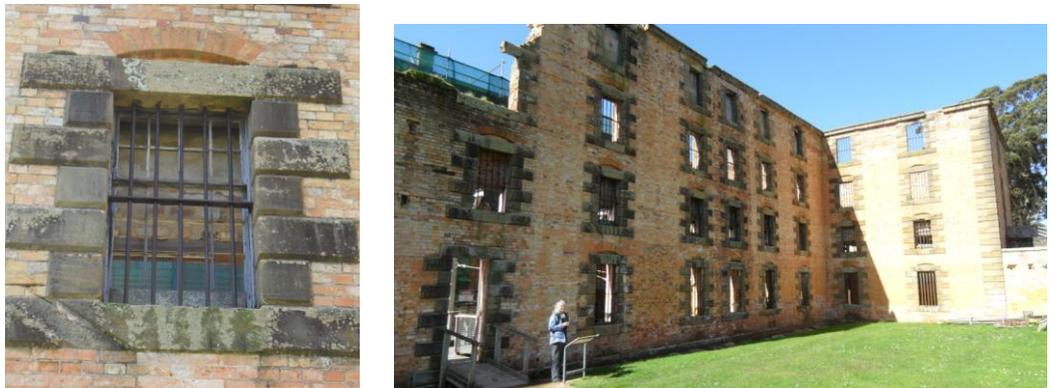
**Figure 52.** View of a southern window with timber framed window, masonry infill behind and metal bars in front (left image) and general view of the south wall of the Penitentiary ruin (right image) [authors 2010]

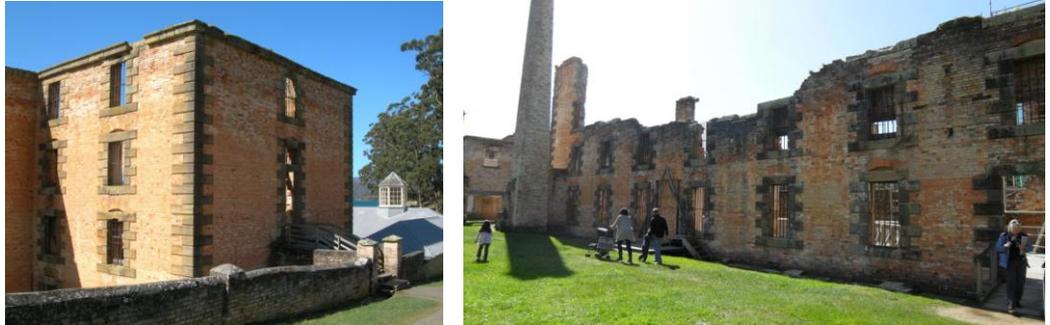
**Figure 53.** View of the southern wing at the east end of the Penitentiary ruin (left image) and general view of the southern elevation of the Penitentiary ruin (right image) [authors 2010]

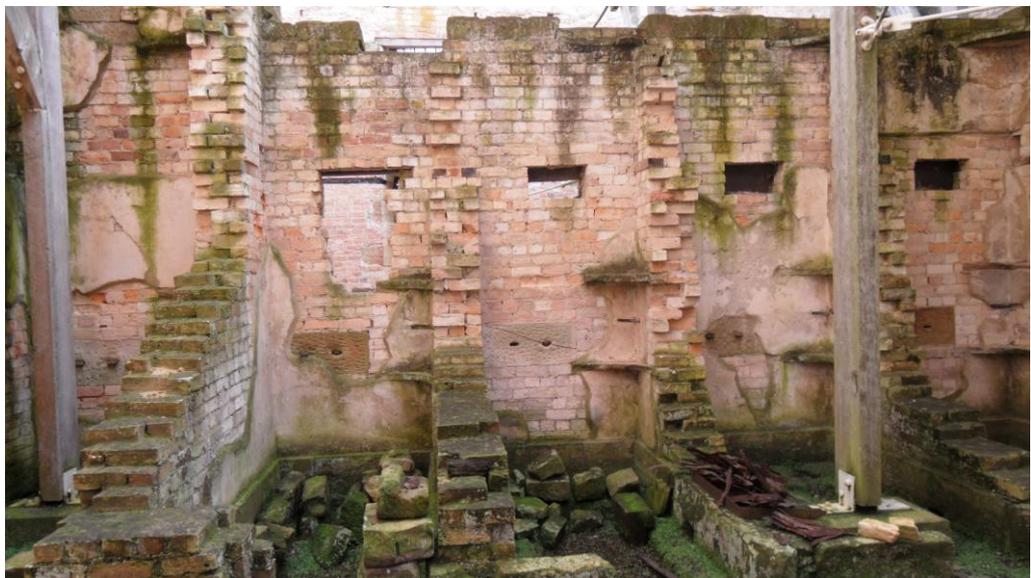
**Figure 54.** View of the remains of a number of cells with the foul air egress vent in the rear wall [authors 2010]

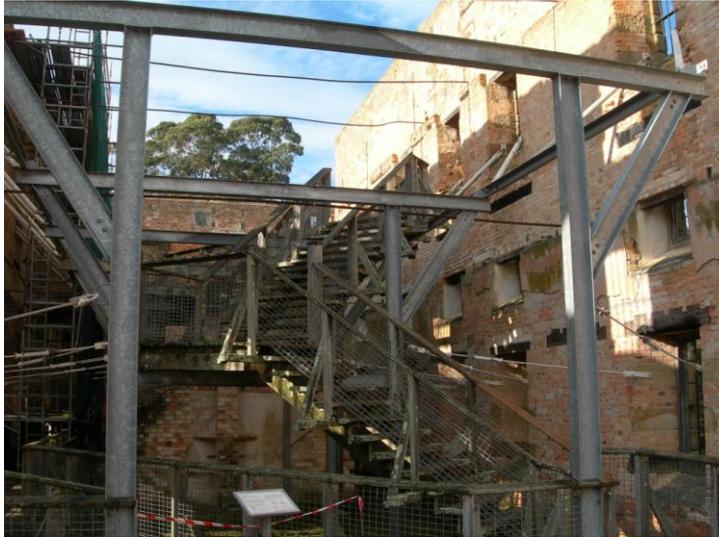
**Figure 55.** Interior view of the Penitentiary ruin structural stabilization infrastructure and walkway. [authors 2010]

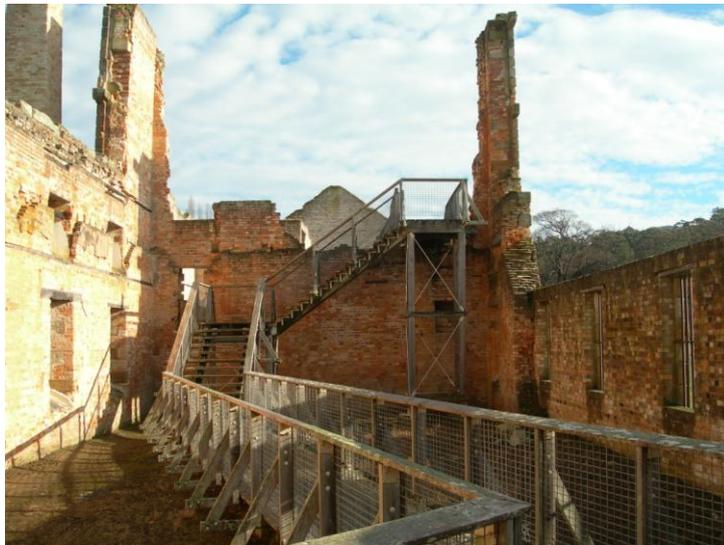
**Figure 56.** View of the walkway in the Penitentiary ruin [authors 2010]

The legibility of the interior of the converted penitentiary building is less discernible than the exterior. The understanding of the remaining ruins and the internal layout of the large structure is very difficult and further confused by the orthogonal and visually intrusive form of the structural bracing and walkway construction. There are no internal floors remaining (other than at ground

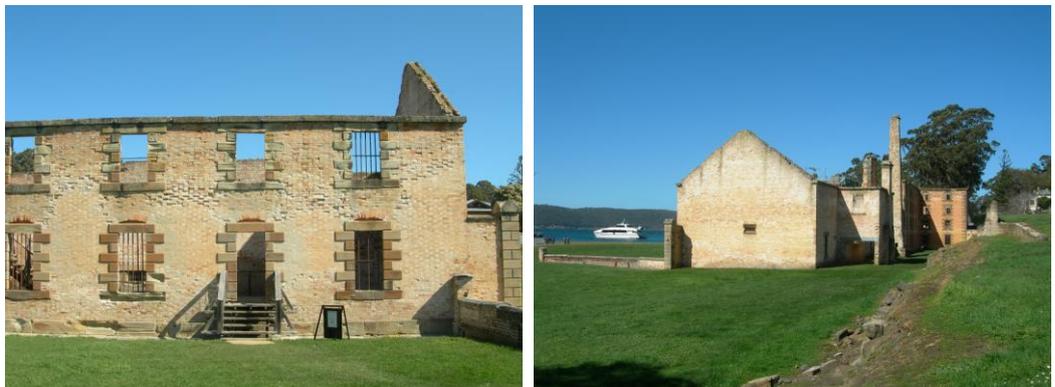
The two-storey Bakehouse/kitchen building was constructed in 1858. The two-storey, gable-roof structure was attached to the west end of the Penitentiary. Like the rest of the building, it had brick walls with stone quoins to the windows and corners, and a timber shingled roof. The size, form and location of the northern windows continued the rhythm established in the original granary/mill structure – including the steel bars over the windows.

**Figure 58.** North elevation of the Bakehouse/Kitchen (left) and the west end wall of the Bakehouse/Kitchen (right) [authors 2010]

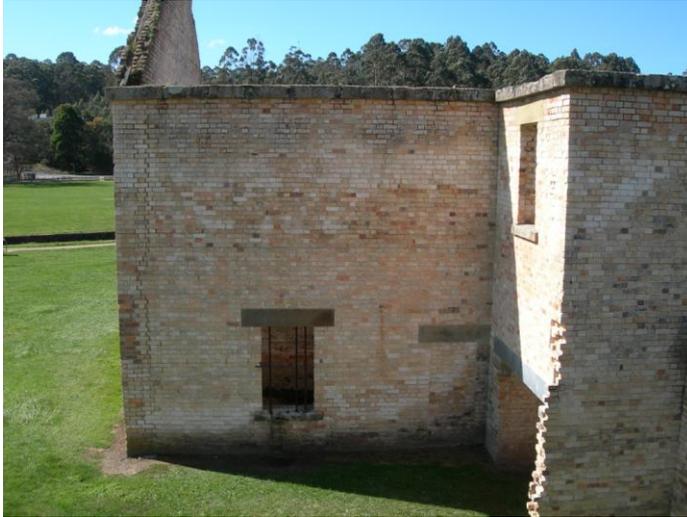
The fire of 1897 resulted in the roof structure being completely destroyed and the bulk of the interior gutted. The perimeter walls remain relatively intact, though the west wall has been reconstructed. Some of the internal walls remain partially intact. The poor quality of the bricks (as discussed in Section 2

History) is clearly evident in the external walls where exfoliation of brickwork has resulted in a mottled finish. The deterioration of the stone base, which has been the subject of structural study and conservation works in recent times is believed to result from the poor foundation conditions, proximity to the cove and water table levels.

**Figure 59.** South wall of the Bakehouse with laundry adjacent [authors 2010]

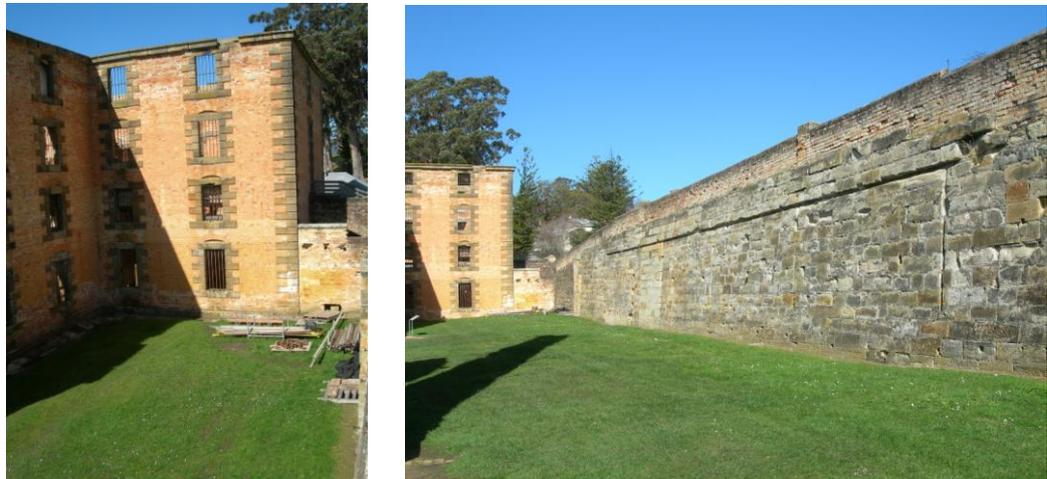
There is no building fabric associated with the ablutions remaining and the area where they did exist is now open lawn. Markings in the rear wall of the penitentiary building and the Champ Street retaining wall provide evidence of the abluion structures that no longer exist.

**Figure 62.** Views of the ablution area behind the converted penitentiary [authors 2010]
