ANDRONAS  
CONSERVATION  
ARCHITECTURE

## **Conservation Management Plan May 2011**

## **Penitentiary Precinct Port Arthur Historic Site Tasmania**

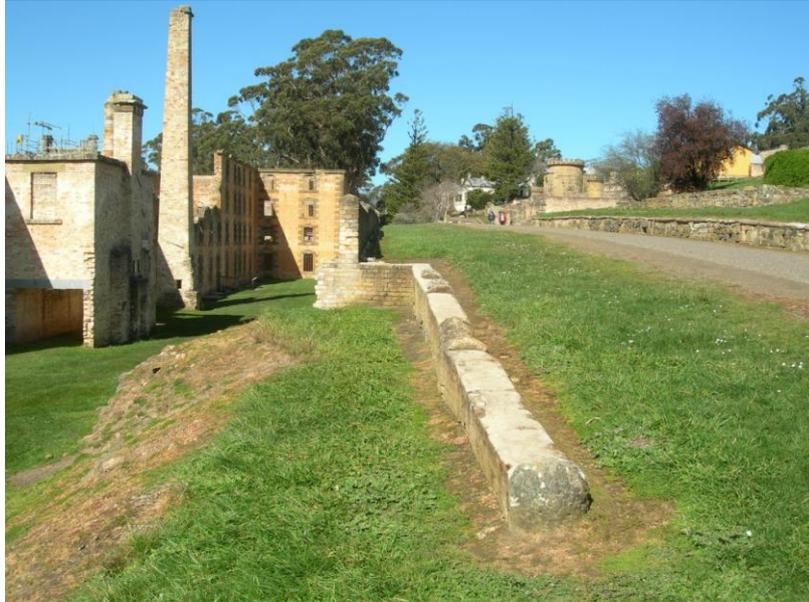
constructed as an attachment to the rear of the bakehouse/kitchen. The large brick chimney associated with the boiler room remains as do parts of the masonry walls of the laundry. The actual layout of the space and the evidence of location of windows and doors is confusing which may be due to changes made to the structure sometime after its original construction in 1858.

**Figure 63.** View of the boiler chimney [authors 2010]

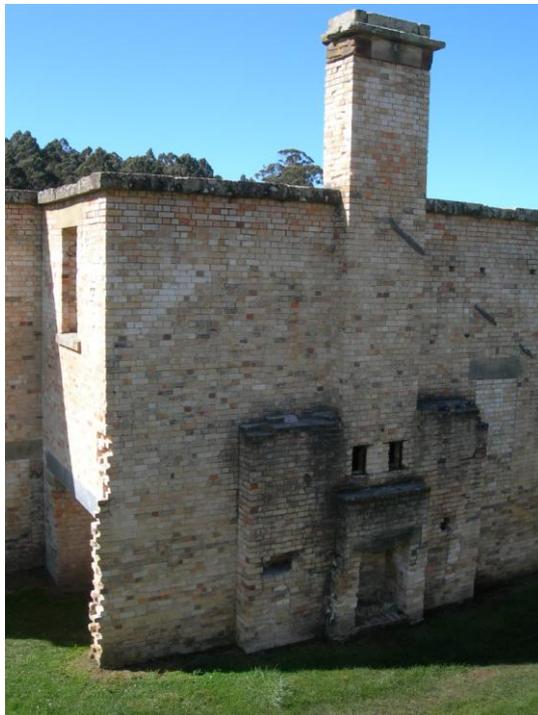
**Figure 64.** View of the laundry ruin [authors 2010]

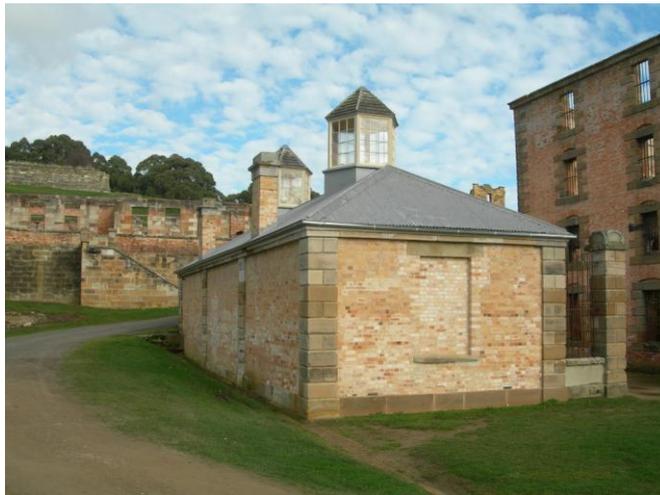
**Figure 66.** North façade of the Watchmen's Quarters [authors 2010]

Prior to its completion in mid 1858, the constables and watchmen had been housed in the penitentiary building. The Watchman's Quarters is a relatively small, single storey L shaped building constructed of brick with a stone base, stone quoins, sills and lintels in a similar style to the converted penitentiary and bakehouse/kitchen buildings. The hip roof, which was originally clad with timber shingles is surmounted by two timber lanterns.

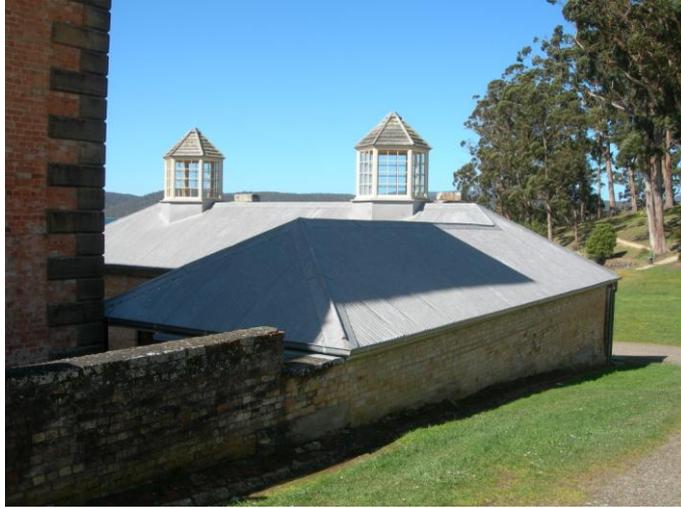
This structure is the only one in the precinct where extensive reconstruction (primarily the roof and lanterns and internal elements) has been undertaken

resulting in an intact building, as opposed to the ruins adjacent. The reconstructed roof is clad in corrugated galvanized iron.

**Figure 67.** South west corner of the Watchman's Quarters [authors 2010]

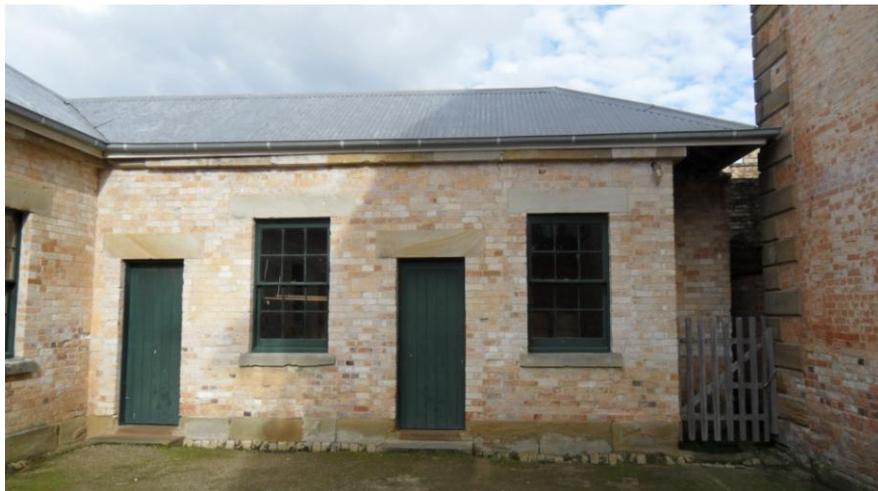
The building consists of four main rooms. The two larger rooms in the north-south wing housed the watchmen in one, and the other, berths for constables and mechanics. The small east west wing at the south end, abutting the Champ Street retaining wall, had a room for the Senior Constable and a cookhouse. Each of these four main rooms is accessed from external doors into the courtyard.

**Figure 68.** Senior Constables Room (left door) and cookhouse [authors 2010]

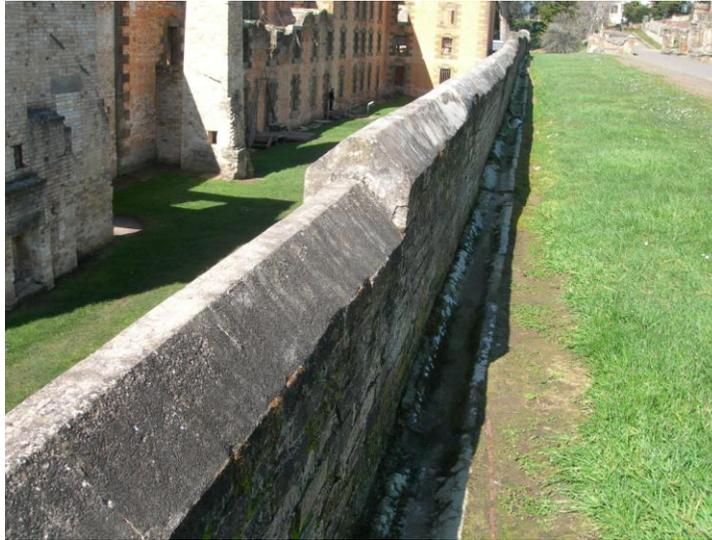
**Figure 69.** A section of the Champ Street retaining wall [authors 2010]

The southern boundary of the Penitentiary precinct is defined by the extensive stone and brick retaining wall which aligns with Champ Street. The retaining wall is over 3 metres in height in sections, has a stepped capping of rendered brickwork with a rounded profile in some parts and triangular in others.

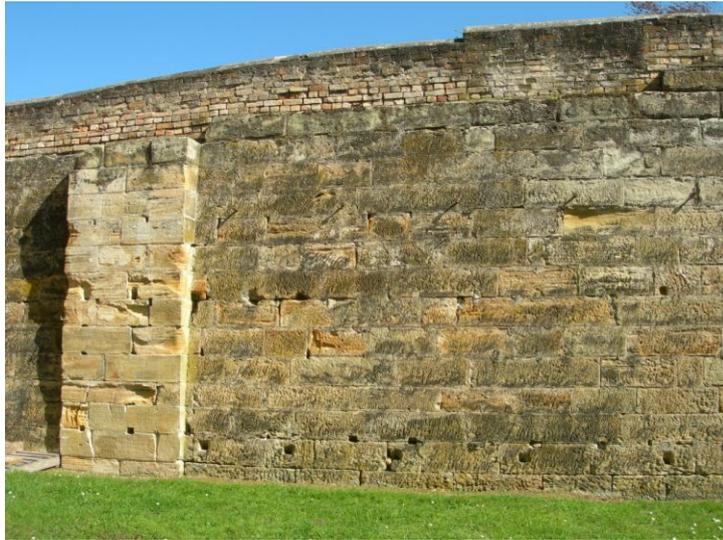
**Figure 70.** Stone pier which originally supported the water wheel flume [authors 2010]

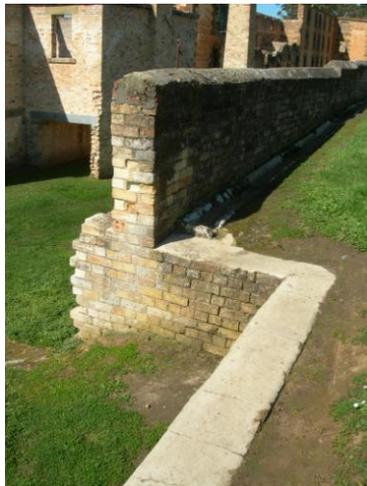
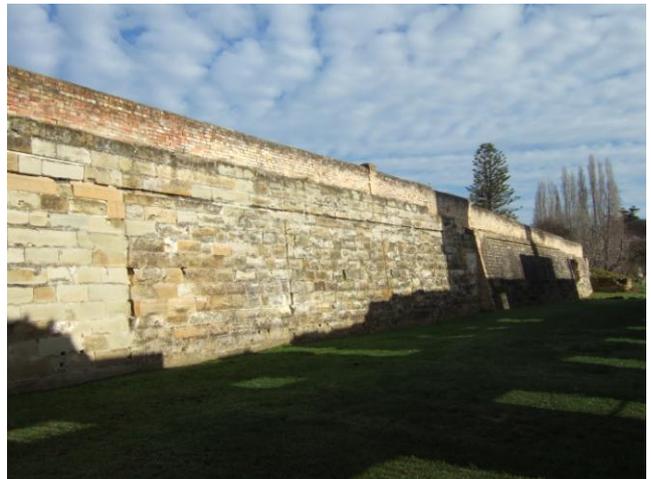
**Figure 71.** Views of the Champ Street retaining wall [authors 2010]

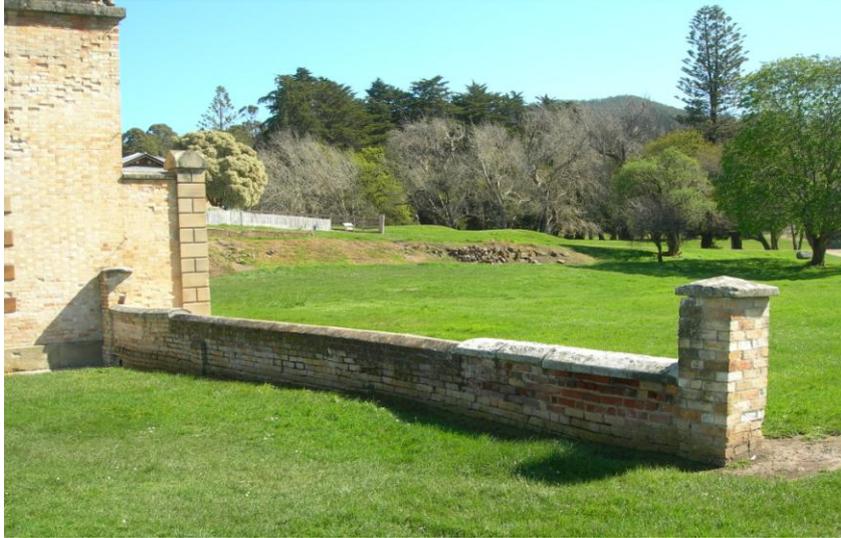
Originally, in front of the converted Penitentiary and Bakehouse/kitchen buildings, was a parade ground defined by a masonry fence (refer to Section 2 History for detail of the parade ground). The only remains of this extensive masonry fencing is a small section at the west end of the Bakehouse – part of which is a reconstruction. The original fence was an elaborate series of masonry pillars and low masonry wall sections with timber pickets above between the pillars.

**Figure 72.** The remaining section and reconstructed pillar of the parade ground fence [authors 2010]

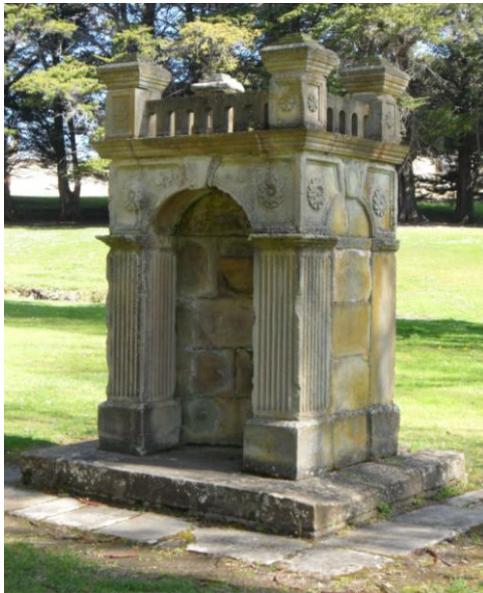
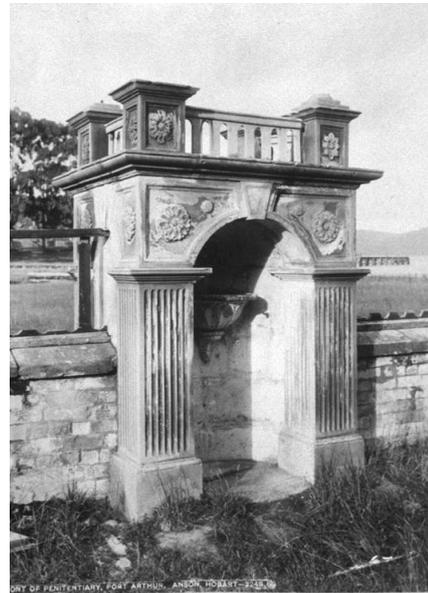
Centrally located in the northern fence of the parade ground was an elaborate masonry water fountain that was intended to keep the working prisoners hydrated. The fountain was removed some time after the decommissioning of the penal station. It was returned to Port Arthur last century and relocated to an open area to the west of the Penitentiary precinct.

**Figure 73.** The parade ground fountain in current location outside the precinct (left) [authors 2010] and the fountain in original location within the parade ground fence [source: <http://catalogue.statelibrary.tas.gov.au/item/?id=201286>]

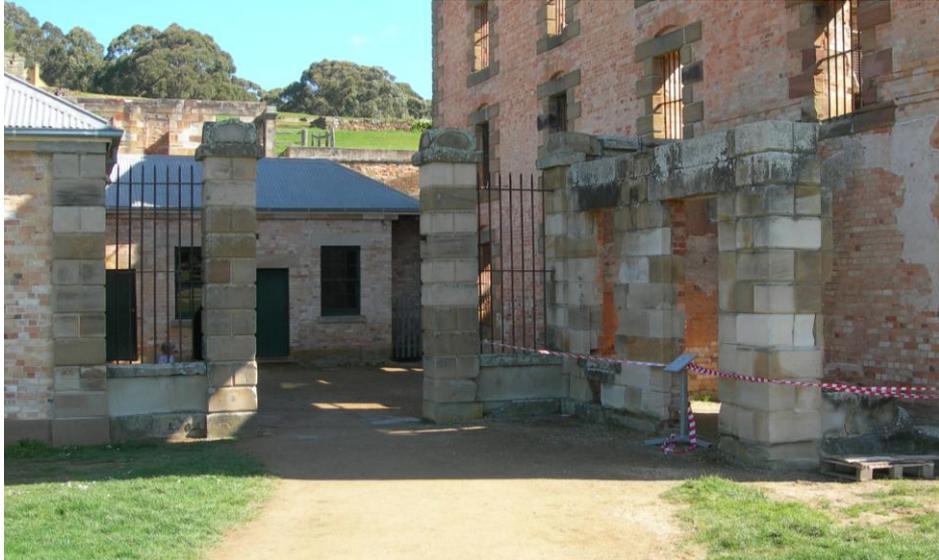
Other stone and masonry wall remnants include the reconstructed masonry pillars and ironwork entrance gates to the Watchmen's Quarters courtyard adjacent to the converted penitentiary building.

**Figure 74.** The reconstructed stone pillars and iron railing to the Watchmen's Quarters courtyard [authors 2010]

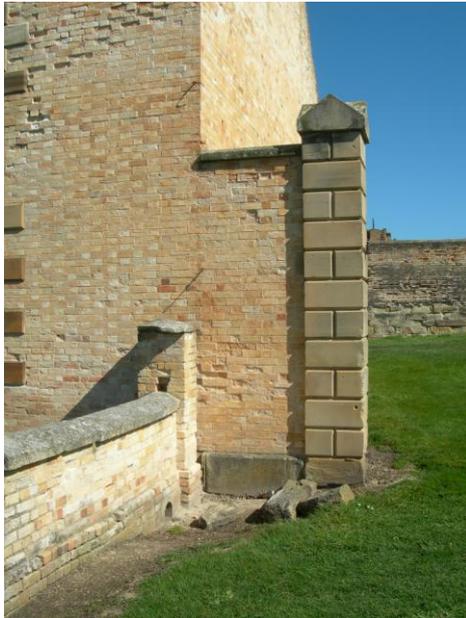
At the west end of the Bakehouse/Kitchen is a section of the masonry wall and gate structure that provided access into the workshops yard. The remaining stone pillar has some of the original ironmongery from the gates intact.

**Figure 75.** Section of masonry wall and stone pillar originally providing access to the workshops yard [authors 2010]

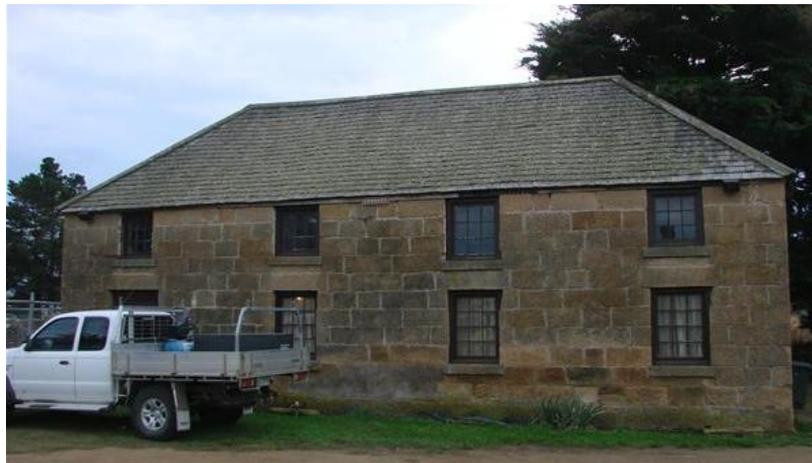
**Figure 77.**  
Callington Flour Mill, (1837) at Oatlands  
(source: [www.abc.net.au/rural/content/2010/s2913740.html](http://www.abc.net.au/rural/content/2010/s2913740.html))

Callington Mill was built in 1836 by John Vincent. By 1840, the mill was producing 20-30 bushels of flour per hour. A steam mill was operating by 1850 and production rose to 5-7 tons of flour per day. The granary and steam mill (above) is a typical colonial stone building with a simple rectangular plan and a hipped shingle roof. Twelve pane rectangular windows with stone sills are symmetrically positioned across the façade.

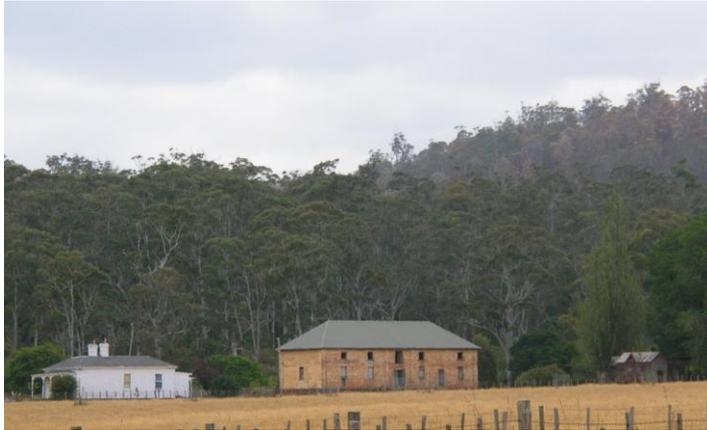
**Figure 78.** Burnside Granary, Dilston, north of Launceston  
(source: [www.heritage.tas.gov.au/media/pdf/January%202008.pdf](http://www.heritage.tas.gov.au/media/pdf/January%202008.pdf))

Burnside granary at Dilston, north of Launceston, is a large, solid and utilitarian structure. The granary was built by a William Bransgrove in the early 19th century, but there is conjecture around the original purpose of the building. Launceston's *Examiner* newspaper reported on 25 August 1909 that 'a Mr Bransgrove erected the [Burnside] building for a distillery, but could not obtain a licence'. In 1938 the same newspaper mentioned that Bransgrove proposed growing cereals on a large scale, so he built a huge granary 90 feet by 30 feet and three storeys high. Typical of this utilitarian building type, the granary is rectangular in plan form with a simple hipped roof and symmetrical openings across the facade.

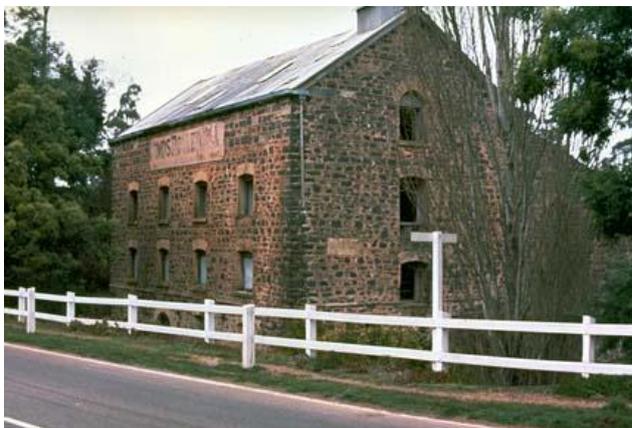
**Figure 79.** Monds Mill, Carrick, Tasmania (c1846) (source: RNE ID 13006)

Monds Mill is another example of a utilitarian mill, with little in the way of architectural ornamentation. It is a simple gable roofed three-storey bluestone watermill with brick voussoirs over openings.

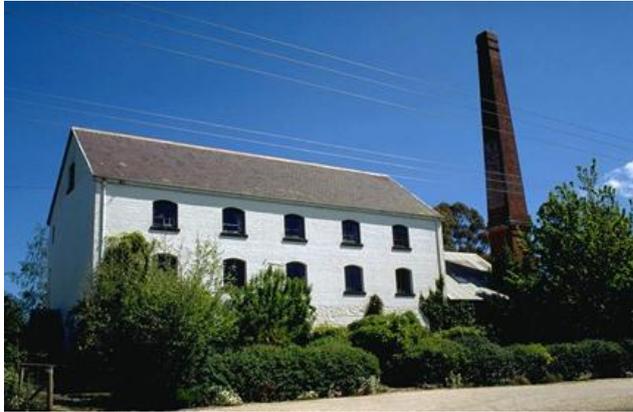
**Figure 80.** *Bowerbank Mill, Deloraine, Tasmania (c1853) (source:RNE ID 12430)*

This Georgian three storey stone mill building features brick quoins, reveals and voussoirs to symmetrically positioned openings and is surmounted by a slate gabled roof. There is a single storey annex with iron gable roof and a tall face brick chimney with decorative cornice.

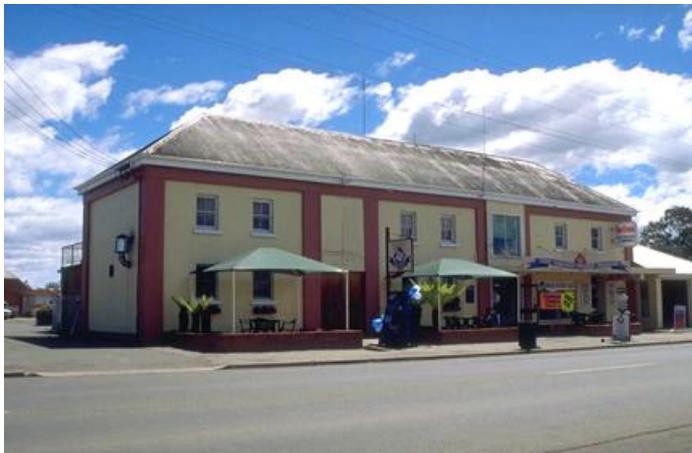
**Figure 81.** *Ritchies Mill, Longford, Tasmania (c1853) (source:RNE ID 12825)*

This two storey Georgian mill building is constructed of brick and stucco. It has a rectangular plan form and is surmounted by a hipped roof with clipped eaves. The multi-pane windows are symmetrically placed in bays across the facade. Internally the building has huge timber members. The remnants of a large brick wall which once enclosed the whole complex are also retained.

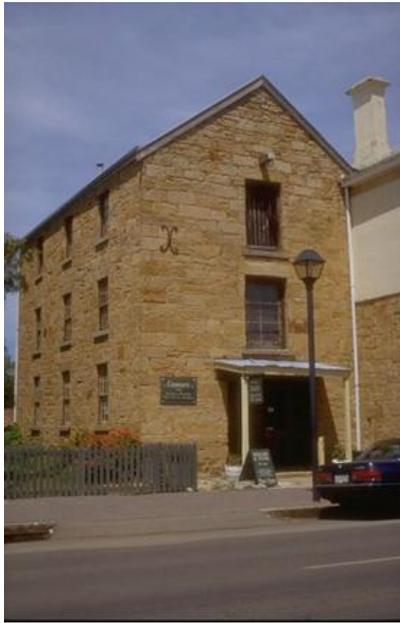
**Figure 82.** Granary, Richmond, Tasmania (c1832)  
(source: RNE ID 11779)

This stone granary is one of a group of Colonial Georgian buildings including a store and residence built about 1832 by James Buscombe. The three storey stone granary has an iron gabled roof and twelve pane windows. The horse operated hoist is still extant.

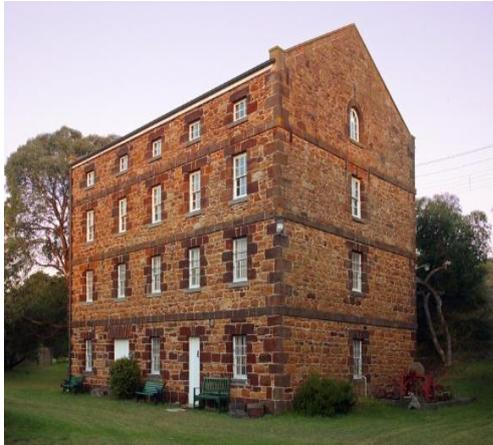
**Figure 84.** Portarlington Flour Mill, Victoria (1856) (source:VHR 13006)

The Portarlington Flour Mill is one of the most distinctive flour mill buildings in Victoria constructed at a time when the Bellarine Peninsula was known as the 'granary of the colony'. The building was initially constructed for the Portarlington Steam Flour Mill Company in 1856, and opened for business in 1857. It is a Victorian Georgian design, with coursed rubble sandstone walls with contrasting quoins and stringcourses defining each floor level. The gabled roof is slate clad. There are timber windows on all four walls, most of which have been reconstructed. With the closure of the mill in 1874 the building served a number of industrial uses including storage for a brick maker; a furniture upholstery factory; a printing ink factory and later for artificial fertilizer production. In the 1960s, the Mill was converted into residential flats, and in 1971 the National Trust of Australia (Victoria) adapted the building for use as a folk museum.

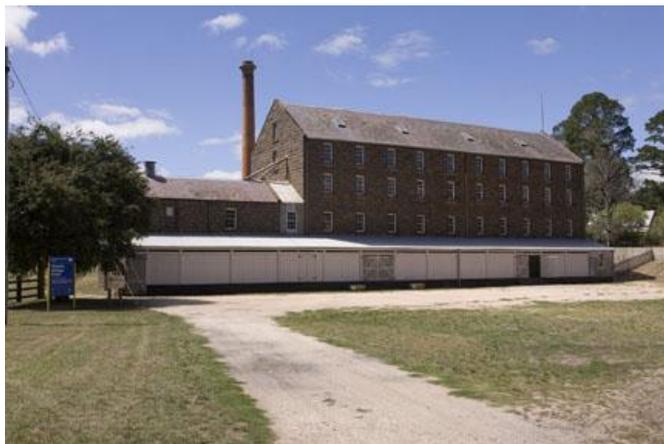
**Figure 85.** Anderson's Flour Mill, Smeaton, Victoria (1861) (source:VHR 1521)

Anderson's Mill Complex, Smeaton, comprises a large bluestone mill building, a 25 tonne waterwheel which is 8.5 metres in diameter, a 23 metre tall brick chimney, bluestone office, stables, granary, blacksmiths shop and residence. The complex was built for the Anderson brothers from 1861. The mill building is a bluestone four storey ten bay structure with an attic storey beneath the gabled slate roof. The water wheel, built by Ballarat engineering firm Hunt and Opie, is fed by a mill race about 900 metres long which commences at a bluestone weir on Birch Creek. When wheat production shifted to the north-west of Victoria, the mill was refitted for oatmeal and continued to function until 1957. The complex still stands near the creek which once drove the mill. This bluestone flour mill is possibly the largest flour mill ever built in Victoria and the most perfectly preserved mill in Australia.

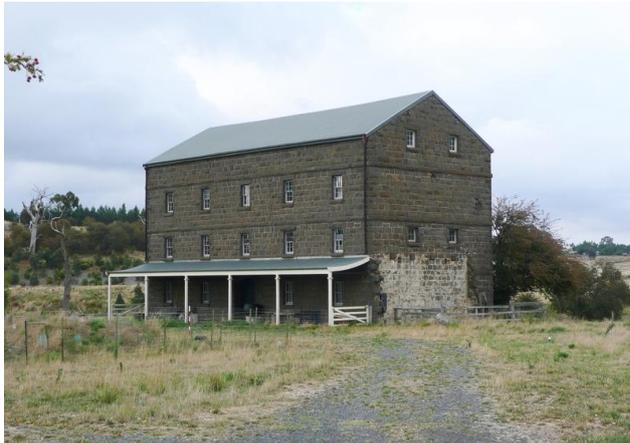
**Figure 87.** Degraves Flour Mill, Kyneton, Victoria (1857) (source:VHR 310)

Degraves Mill stands beside the Campaspe River, on the site of the Karlsruhe Run which had been established by Charles Ebden in May 1837. The mill was built for William Degraves in 1857 to a design by F M White. Degraves also had a second mill built in the Kyneton district, at Riverview in 1859. The mill is a

large coursed bluestone structure articulated with string courses at floor levels and surmounted by a gabled roof. It is rectangular in plan, measuring about 20 x 10 metres, and has five main bays, defined by small multi-paned windows with expressed stone sills and window heads. Internally, the posts, beams and surviving joists are of Oregon. The original shingle roof is preserved beneath corrugated iron. The verandah is a recent conjectural reconstruction.

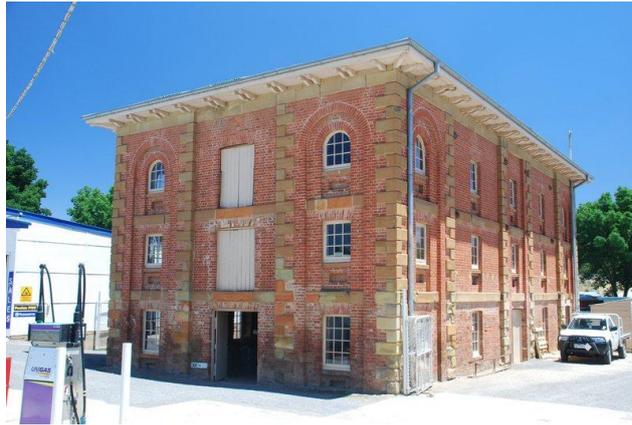
**Figure 88.** Flour Mill, Castlemaine, Victoria (1856) (source: VHR 395)

The steam driven mill building is a three storey Georgian-style brick and stone structure designed by Thomas Shephard. The building is symmetrical plan and elevation and features brick blind arcades, multi-paned windows and stone quoining. The mill is considered to be one of the finest in Victoria.

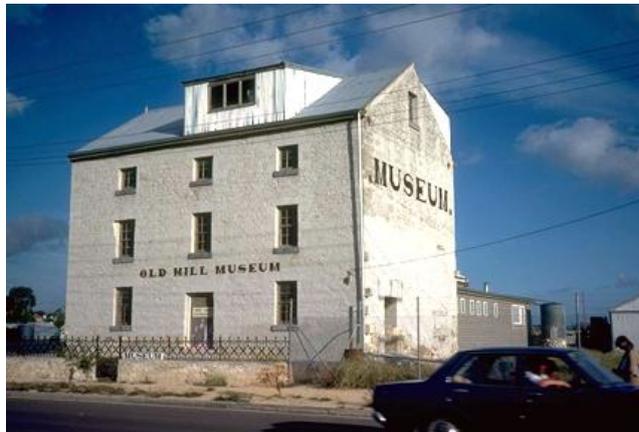
**Figure 89.** Flour Mill, Naracoorte, South Australia (1870) (source: RNE ID 7992)

This three storey mill with limestone walls, dressed quoins and a gabled corrugated iron roof was built by Smith and Agar. It was originally operated by water power from the Naracoorte Creek. In 1892, new machinery was added and the mill continued until the early 1930s.

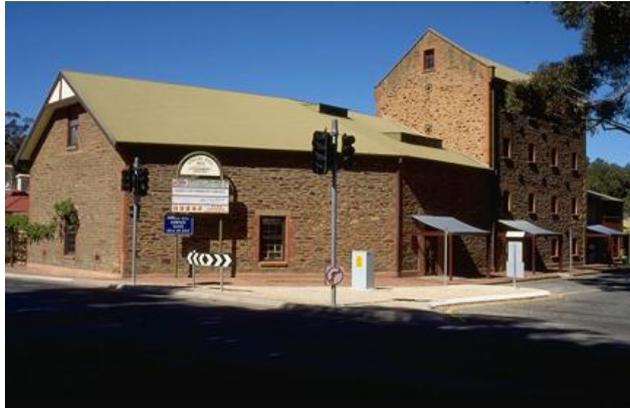
**Figure 90.** Flour Mill, Gawler, South Australia (1855) (source: RNE ID 6084)

The Mill has random stone walls and the four storey portion of the complex has four bays, with little exterior ornamentation. Internally, the timber floors are supported by sturdy posts and beams. The mill was erected in 1855 by the Harrison brothers. It was extended some time before 1880 and by that time was four storeys high and had associated offices, a timber yard, weighbridge, a blacksmiths shop and forge. It was one of three flour mills in Gawler. In 1915, the mill was gutted by fire and when it was rebuilt the following year, only the central section was completed to four levels. The mill continued to operate until about 1917.

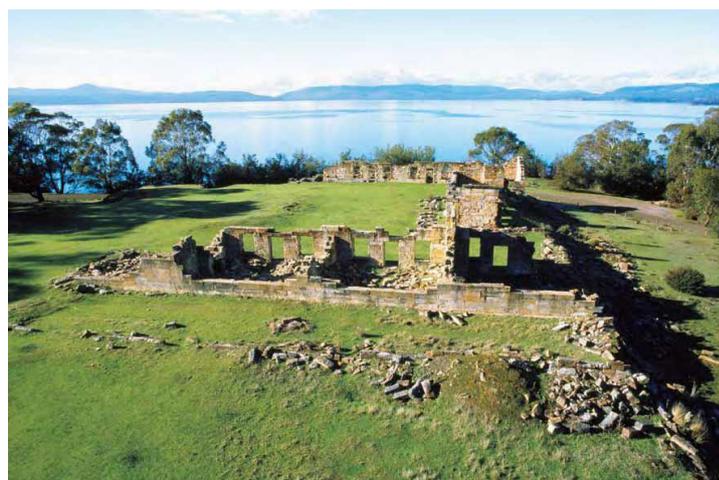
**Figure 91** - Coal Mines Historic Site (source: World Heritage nomination)

The site comprises over 25 substantial building ruins as well as remains of coal mining activities. The remaining features comparable to those in the Penitentiary precinct at Port Arthur include the main convict station, which is overlooked on higher ground by military and civil buildings (a similar arrangement as at Port Arthur). The prisoner barracks ruin was originally two large stone buildings that housed up to 170 convicts within a fenced compound. Underneath the barracks remain 16 solitary punishment cells. There are also archaeological remains of over 100 separate apartment cells. Another 36 alternating solitary punishment cells were built below the separate apartments and 18 of these remain. The Officers' Quarters and the Assistant Superintendent's House were located within the convict precinct to provide surveillance. The site also includes houses for the Surgeon, Coxswain, Commissariat Officer and Catechist. The Chapel (which also functioned as a school house) is prominently situated in the heart of the main station. Remains of the Bakehouse, Workshops, and the Engineer's Store are also visible. The Coal Mines now operates as an historic site<sup>90</sup>.

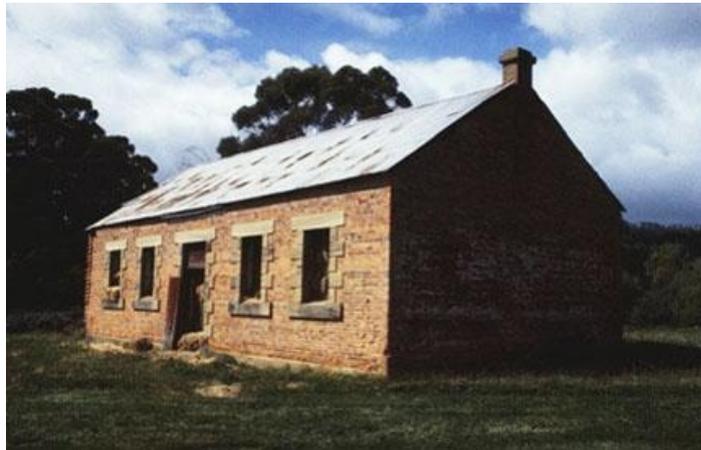
**Figure 93.** *Cascades Probation Station Mess Hall, Tasman Peninsula (source: RNE ID 11983)*

The use of quoins and dressings to openings contrasting with walls was a common treatment for penal station buildings in VDL. The former Mess Room at Cascades Probation Station on the Tasman Peninsula employs this detailing. This station was in operation from 1842 to 1857.

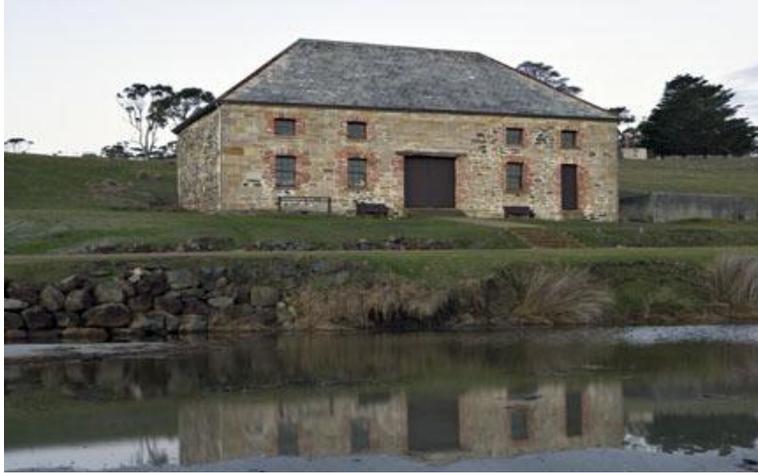
**Figure 94.** Darlington Commissariat Store, (c1825) (source:NHL ID 105933)

The Commissariat Store of c1825 at Darlington Probation Station, Maria Island, is a larger structure than the Cascades Probation Station Mess Hall, but has similar articulation. Here, the walls are stone, with contrasting brick window dressings. At the time of its construction, it was believed to be the largest edifice in all of VDL, and possibly the Australian colonies.

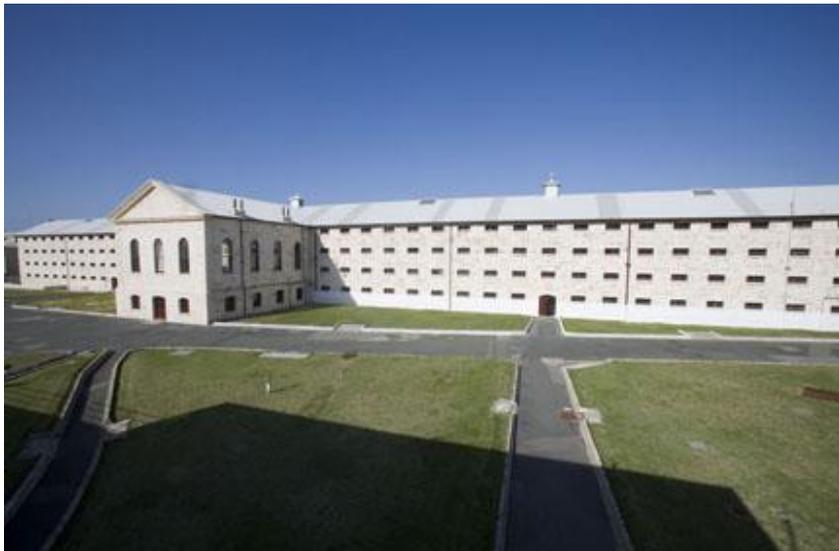
**Figure 95.** Freemantle Prison, (source:NHL ID 105762)

The design by Captain Henderson was based on the principles of prison design developed by Joshua Jebb at Portland and Pentonville in England. Those models were modified to use local materials and stripped of architectural refinements because of the shortage of funds and skilled labour.

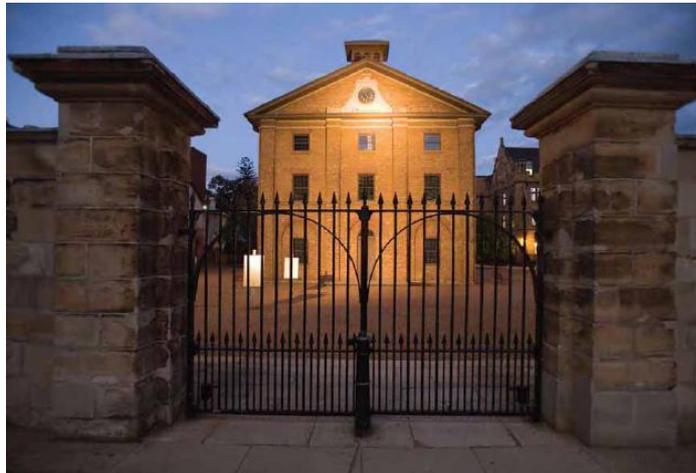
**Figure 96.** Hyde Park Barracks (Source: World Heritage nomination)

The Hyde Park Barracks was built in 1819 to house, clothe and feed convict men and boys. This impressive brick building and walled compound, located at the head of Sydney's historic Macquarie Street, was designed by convict architect Francis Greenway. After 1848 the main dormitory held newly arrived female immigrants while a handful of government agencies made use of surrounding buildings. In 1862, separate wards for destitute women were added upstairs and the Barracks became known as the Hyde Park Asylum. Sydney celebrated the 50th anniversary of Queen Victoria's reign in 1887 with the construction of major public buildings and monuments. The Hyde Park Barracks became a hub of government departments and renamed Chancery Square. Until the late 1970s, thousands of public servants, legal workers and litigants occupied dingy office spaces, courtrooms and corridors, scattered throughout the increasingly crowded complex. Today the Hyde Park Barracks is a museum.

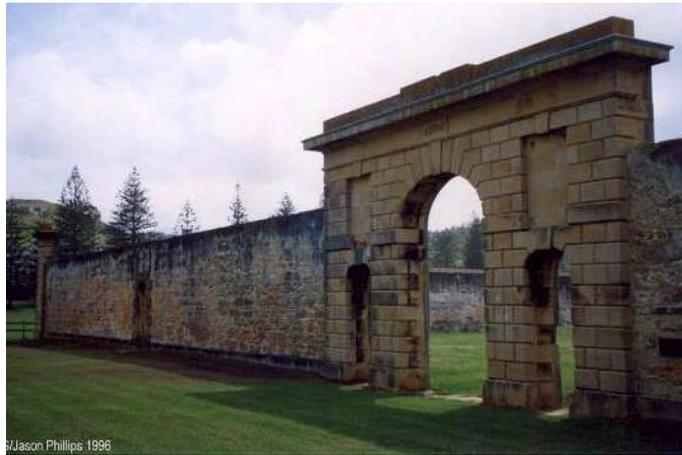
**Figure 97** *New Gaol, Norfolk Island (Source: Norfolk Island: The Website)*

The Gaol was commenced in 1836 but was not completed until 1847. It was built with the aim of reform by isolation, and contained a central pentagonal building of 84 cells, two lockup rooms ten turnkey's rooms and ten yards. Each cell had stone walls and floors and a timber ceiling; was 6ft long, 5ft wide, almost 11ft high, and was occupied by up to 3 prisoners. The complex also contained another 40-cell block, two service buildings, 12 solitary confinement "apartments" about which the Royal Engineer wrote "...the convicts regard the...new cells with dread...they are the most perfect specimens of prison construction I have seen...", and two "dumb cells" which prevented the transmission of light and sound - sending their occupants insane.
